# STUDY

RENOVATION / RESTORATION  
OF THE  
TOWN HALL BUILDING  
WARREN, MASSACHUSETTS

JULY 25, 1997

REINHARDT ASSOCIATES, INC.

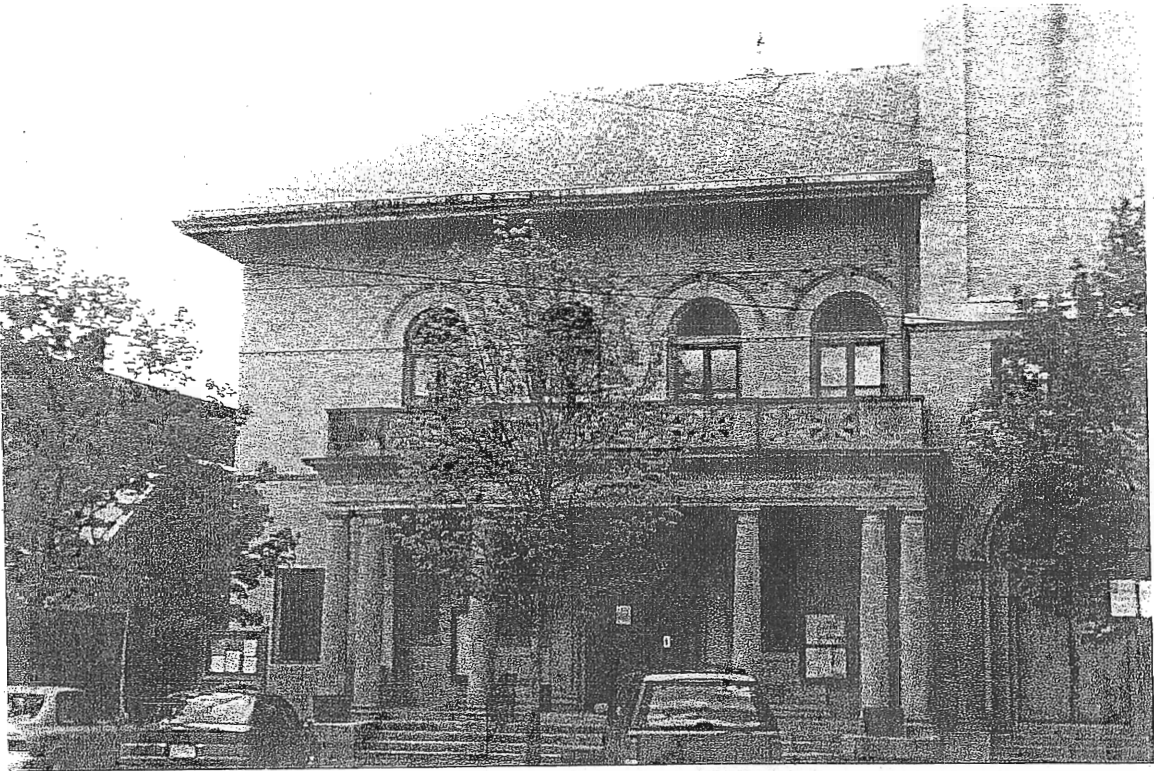
The limestone columns and railed Main entrance Portico are in reasonably good shape with the exception of some of the joints where rail and column abutt and/or adjoin, these joints are in need of repointing and caulking. The Portico limestone should be cleaned, as should the limestone trim around the exit doors on the East, North and West sides of the building. Some pointing of limestone joints should also be provided.

**WARREN TOWN HALL  
FRONT ENTRANCE PORTICO**

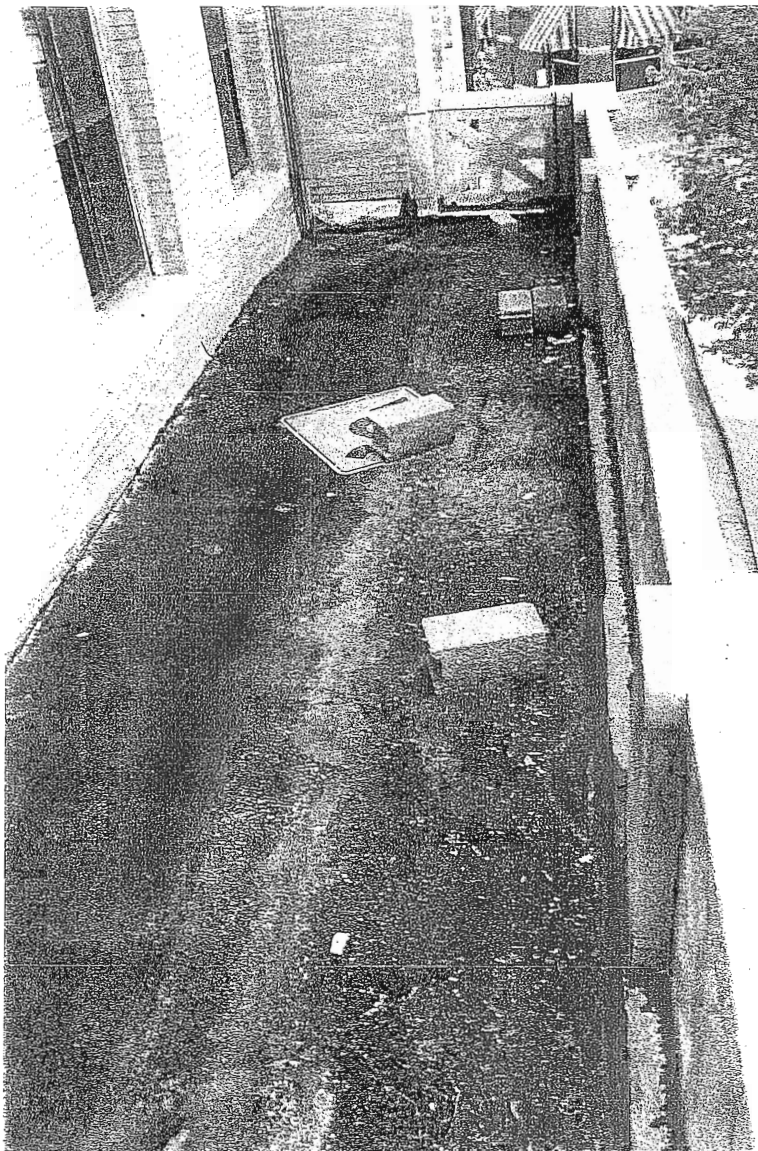
The front entrance Portico is roofed with built-up tar and gravel whose life expectancy has generally been expended and is in need of replacement. Refer to Photo Page 4.

WARREN TOWN HALL  
FRONT ENTRANCE ROOF

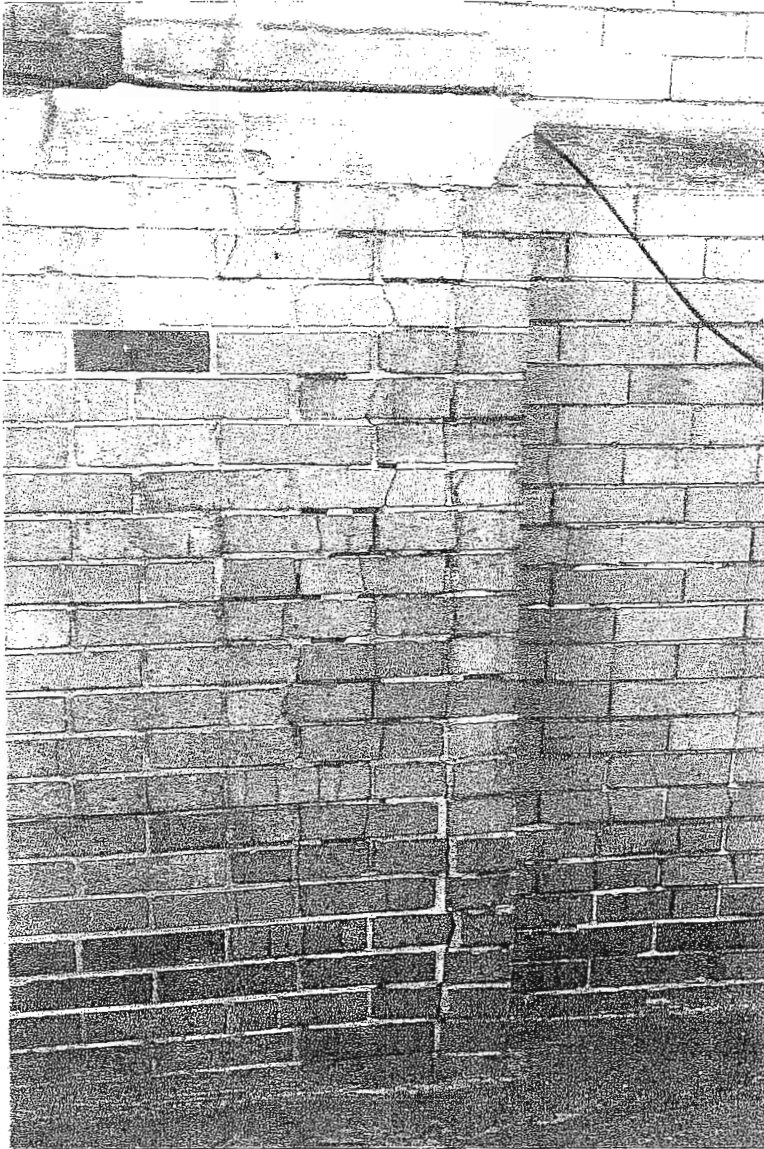
On the South (Powder Mill Brook) side certain areas of brick joints have deteriorated and need repointing. The Southwest area beyond the chimney also needs repointing work. The brick joint between the original building and the Memorial Hall/Stage Addition is now open to weather and requires new caulking/sealant.

BRICK CRACKS & JOINT  
DETERIORATION AT  
SOUTHWEST AREA OF  
THE BUILDING.

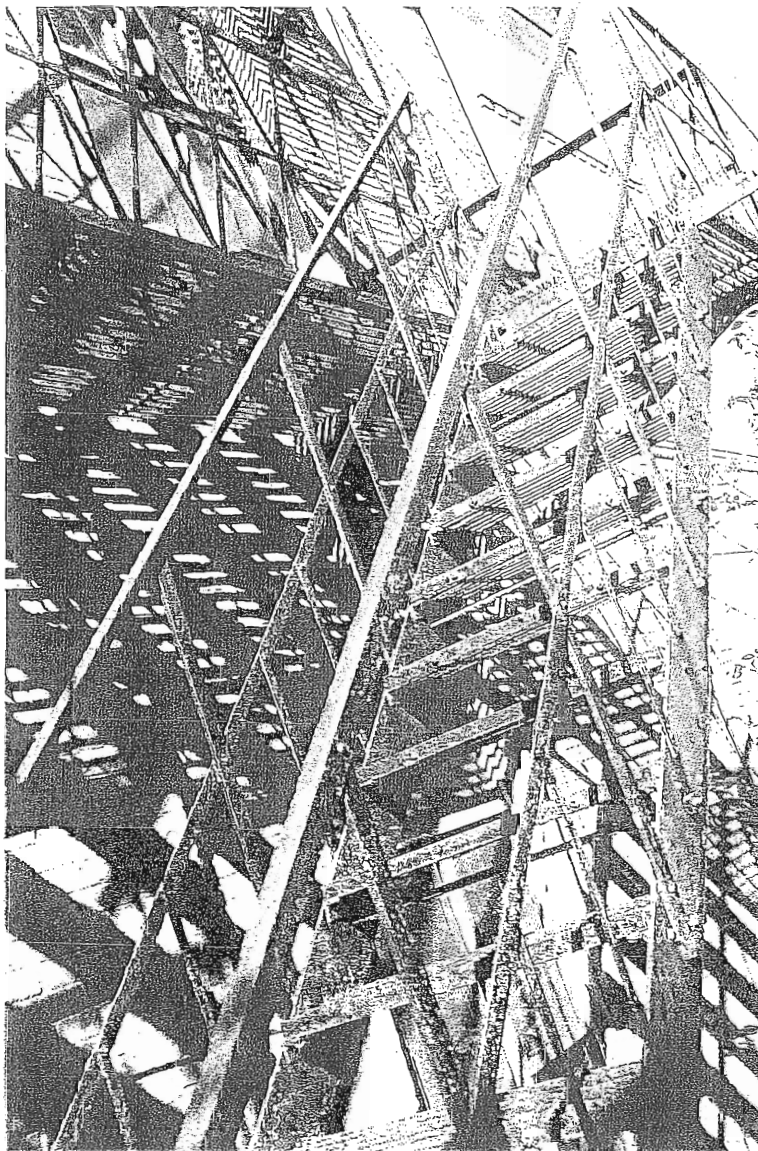
The existing fire escape which serves as the secondary exit stair from the Balcony to the exterior grade appears to be structurally sound, nevertheless the lack of maintenance, primarily the absence of thorough scraping and painting of the steel members is resulting in rust and deterioration which weakens structural components. The determination of the final use or non-use of the fire escape stairs may rest with decisions later made as to the further use or non-use of the balcony or later decision made regarding the use or function of the building. This does not preclude the necessity of much needed maintenance in the form of scraping and painting at the present time. See Photo Page 7.

FIRE ESCAPE -  
LEADING FROM BALCONY  
TO GRADE  
(NOTE RUSTING CONDITION)

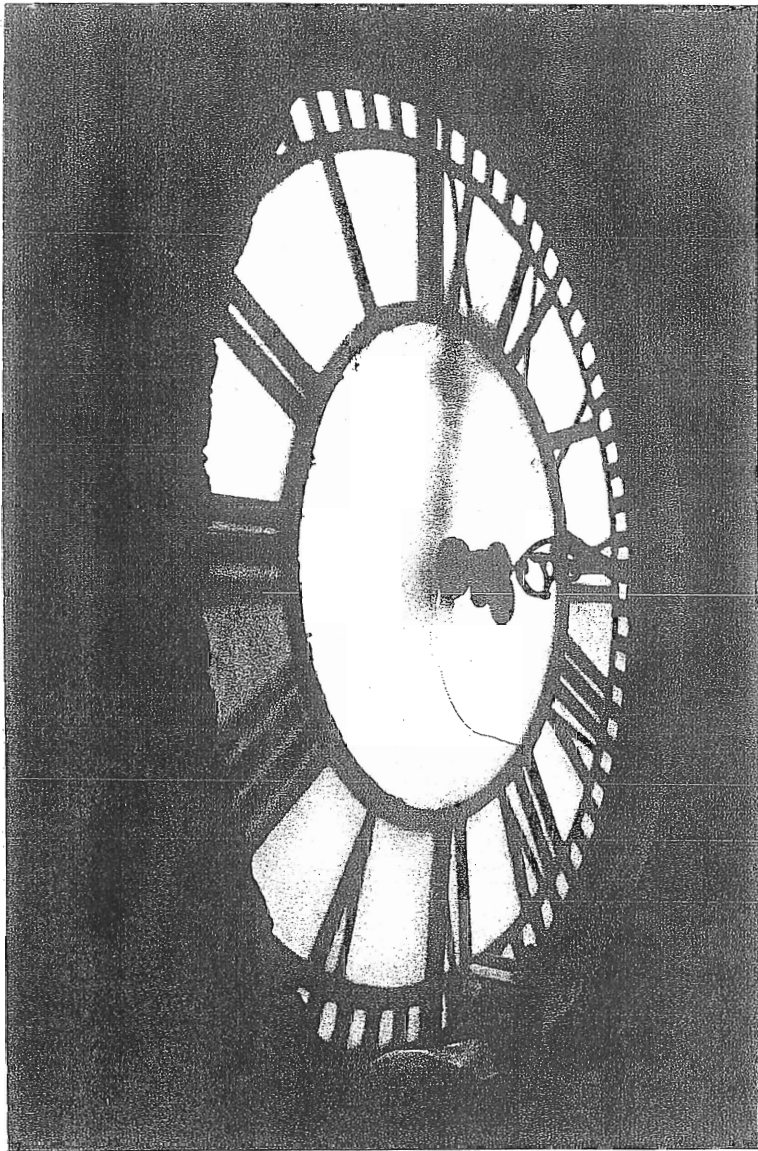
The glass clock face on the West side is cracked and in need of replacement. General cleaning and removal of debris is necessary. Exposed brick walls in these areas are in good condition.

CLOCK FACE  
(FROM INTERIOR)  
NOTE CRACKED FACE

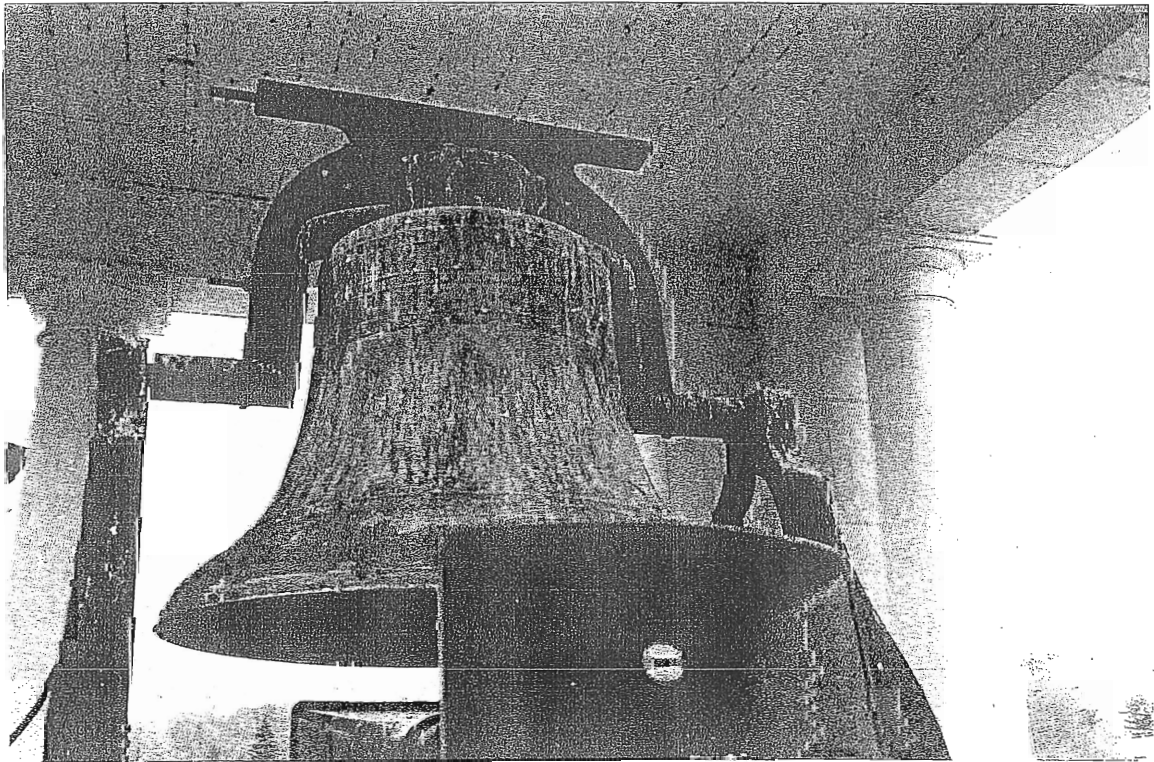
**OPEN BELL LEVEL  
(NOTE SULLIED BELL FROM ROOSTING PIGEONS/BIRDS)**

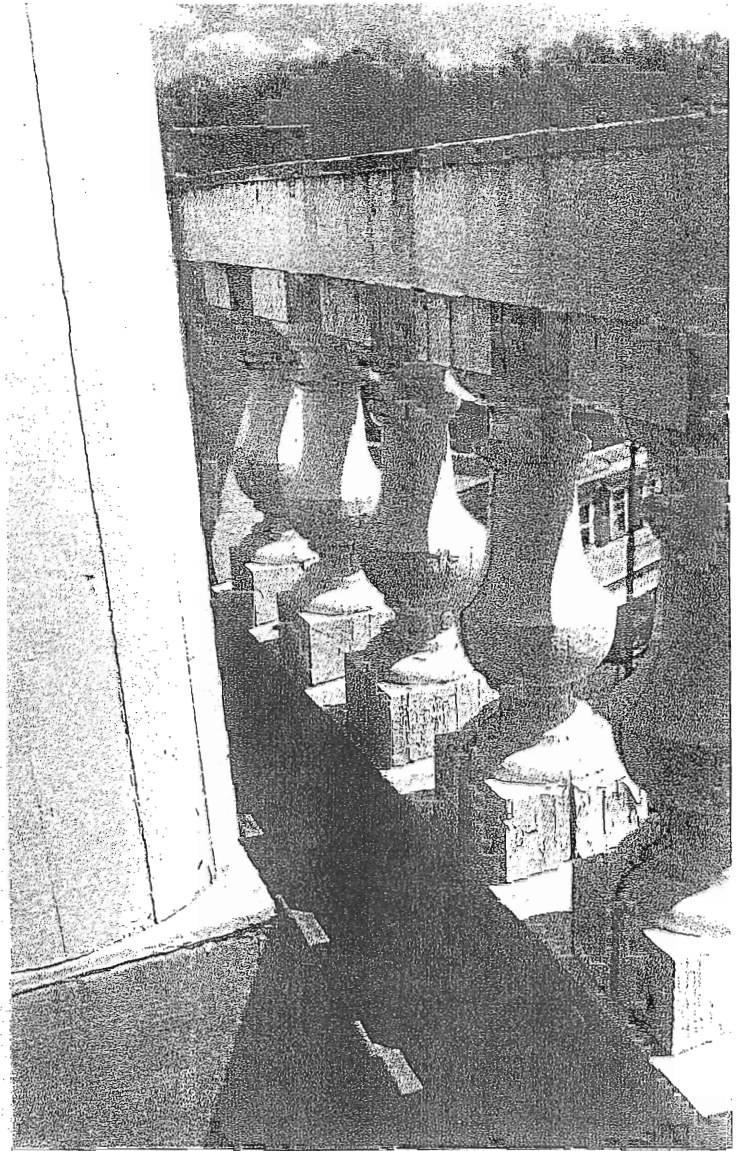
OPEN BELL LEVEL  
DETAIL OF BALLUSTRADED  
WOOD RAIL  
(NOTE CRACKED CONDITION)

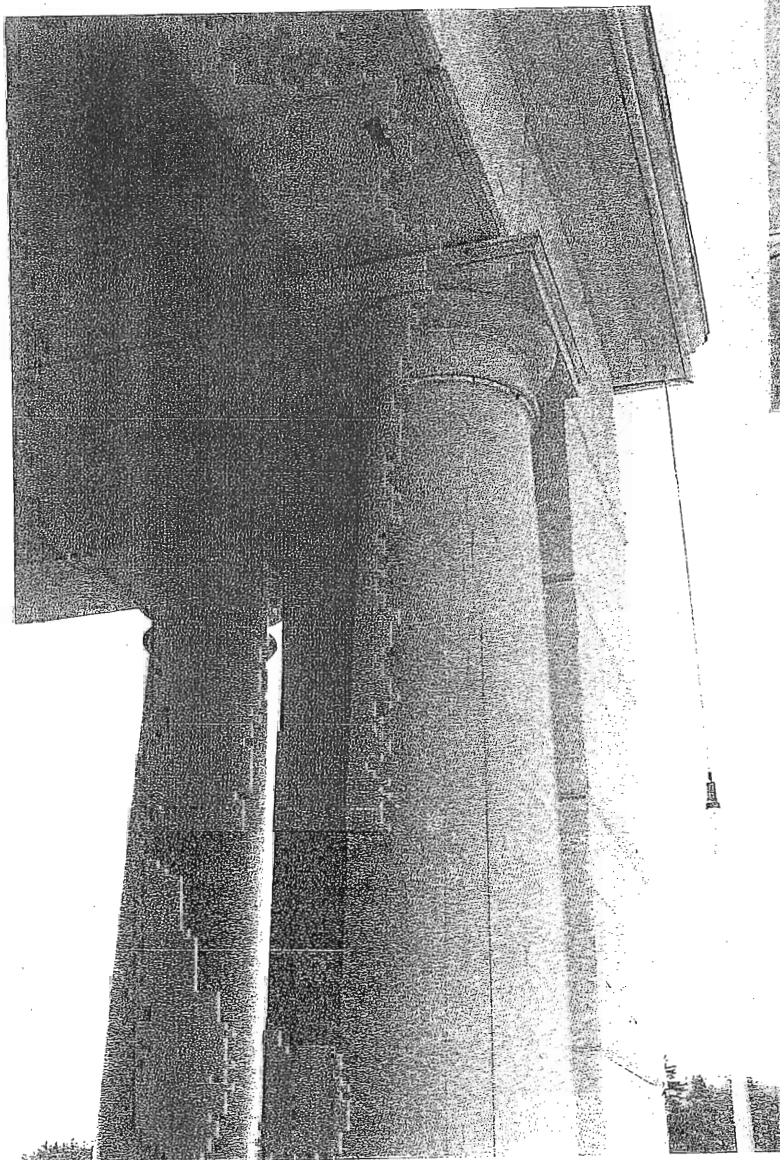
OPEN BELL LEVEL  
DETAIL OF WOODEN  
COLONNADED/QUOINED  
CORNER (NOTE OPEN  
SEAMS & CRACKS IN COLUMNS)

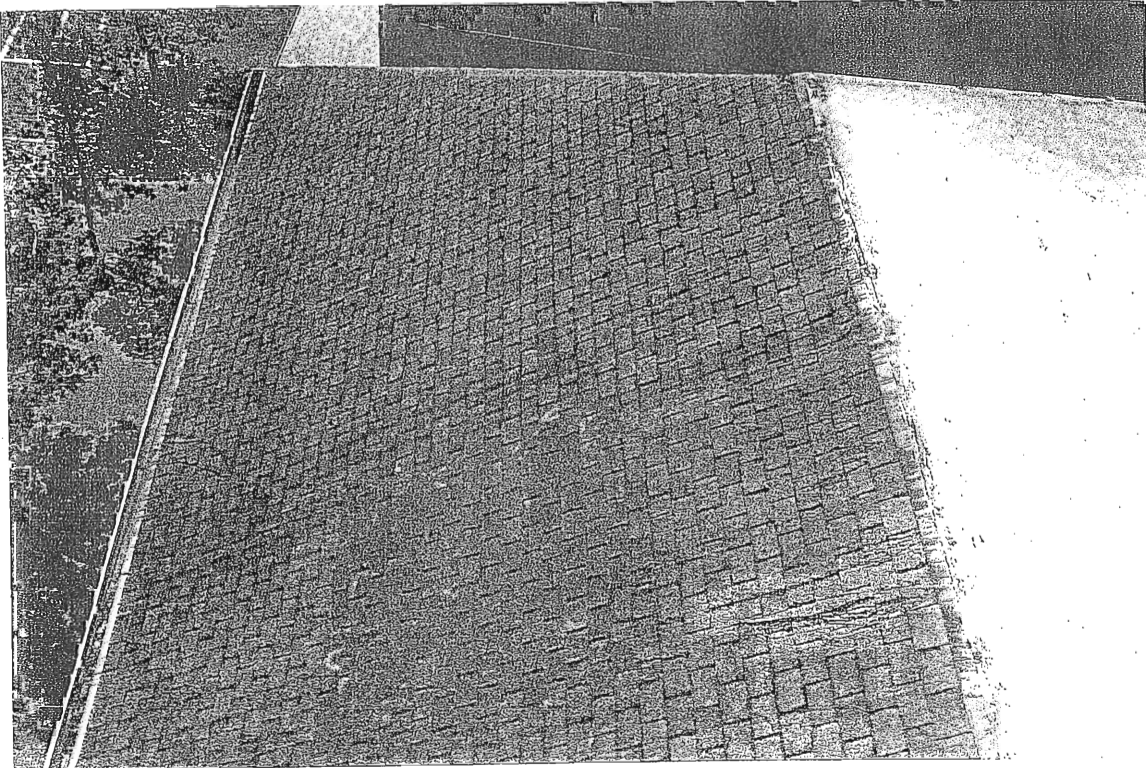
The flat area of the roof is a smooth surface built-up roofing in poor condition and in need of replacement, with little, if any life expectancy. The sloped area of the roof is roofed with slate shingles in poor condition and in need of repair. Without repair this roof life expectancy is estimated at five years at which time some definite measures of repair and/or replacement will be necessary. Repair of the built-up roof in the near future should extend the life expectancy of the roof to thirty years and the slate roof to sixty years.

**SLOPED SLATE SHINGLE AREA OF ROOF  
LOOKING DOWN FROM BELL LEVEL  
(NOTE REPAIRED AREA NEAR BOTTOM OF PHOTO)**

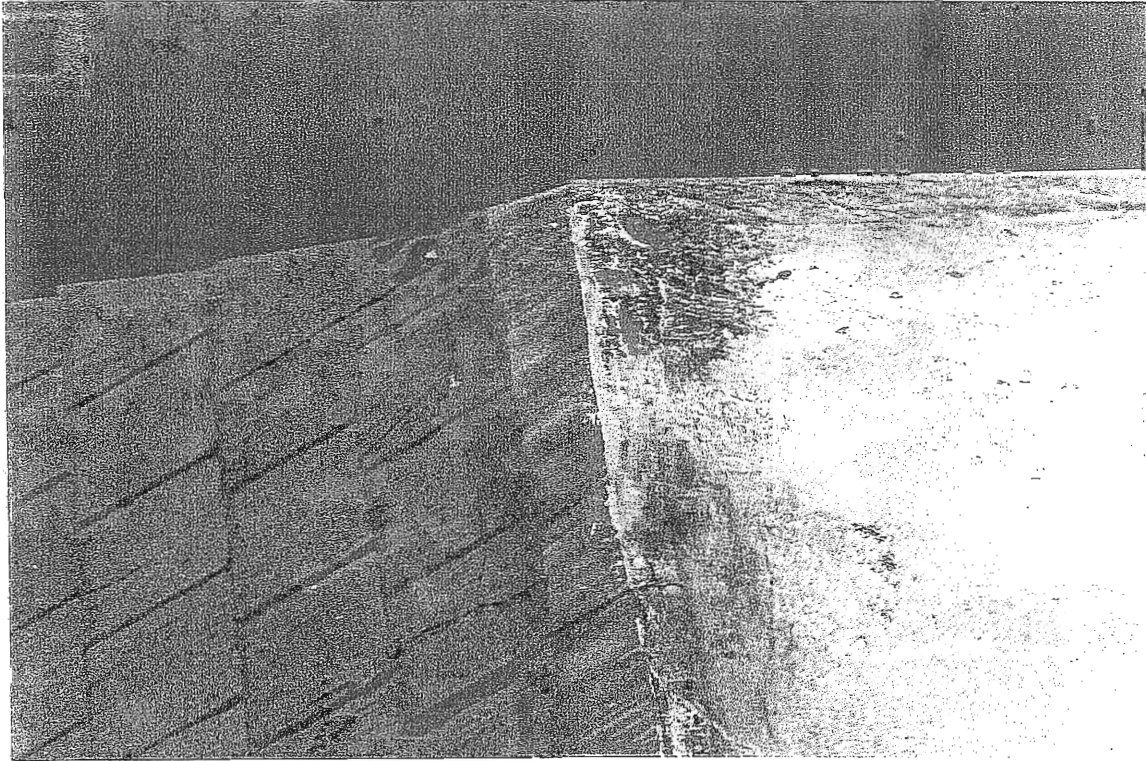
The metal and built-up flashings are in poor condition and in need of replacement to greatest extent possible.

**DETAIL OF CORNER "FLAT" ROOF TO SLOPED SLATE SHINGLED ROOF -  
NOTE POOR CONDITION OF FLASHING & CRACKED SHINGLES**

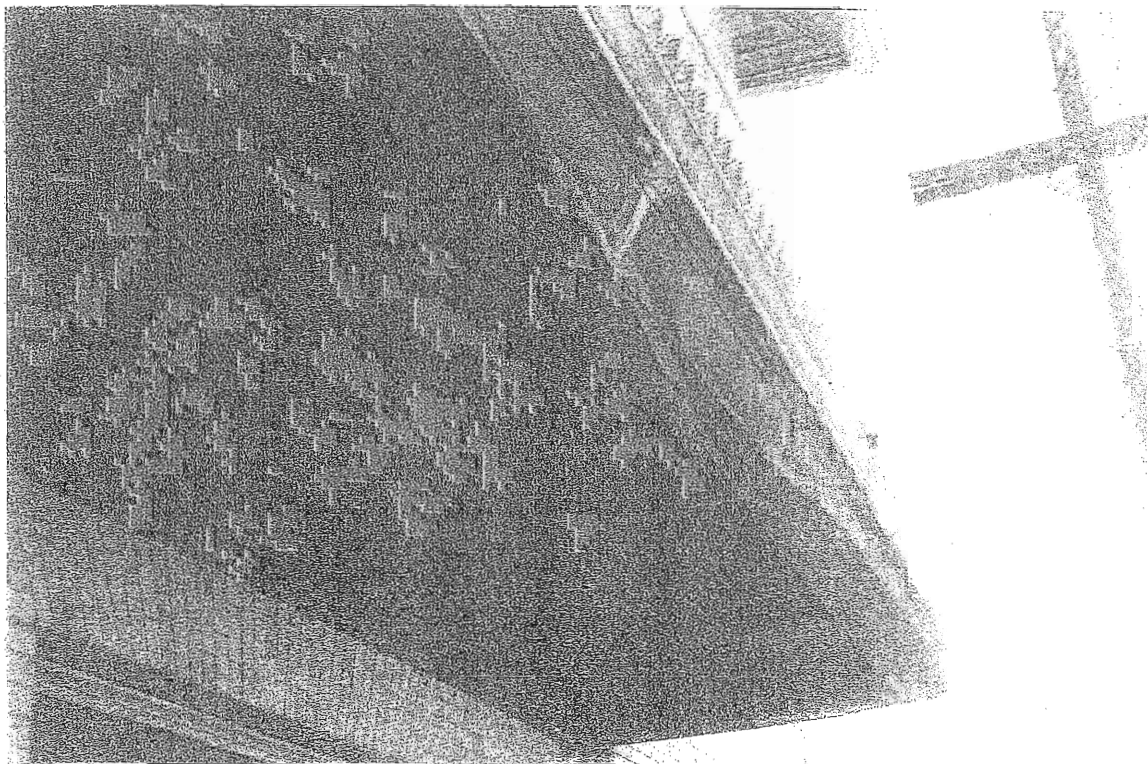
The Main Street canopy extending over the sidewalk protecting the entrance to Memorial Hall is totally clad in copper and has been damaged by a vehicle or other external source and is in need of repair. Refer to Photo Page 13.

**COPPER COVERED MARQUEE TYPE ROOF AT MEMORIAL HALL ENTRANCE  
NOTE DAMAGE**

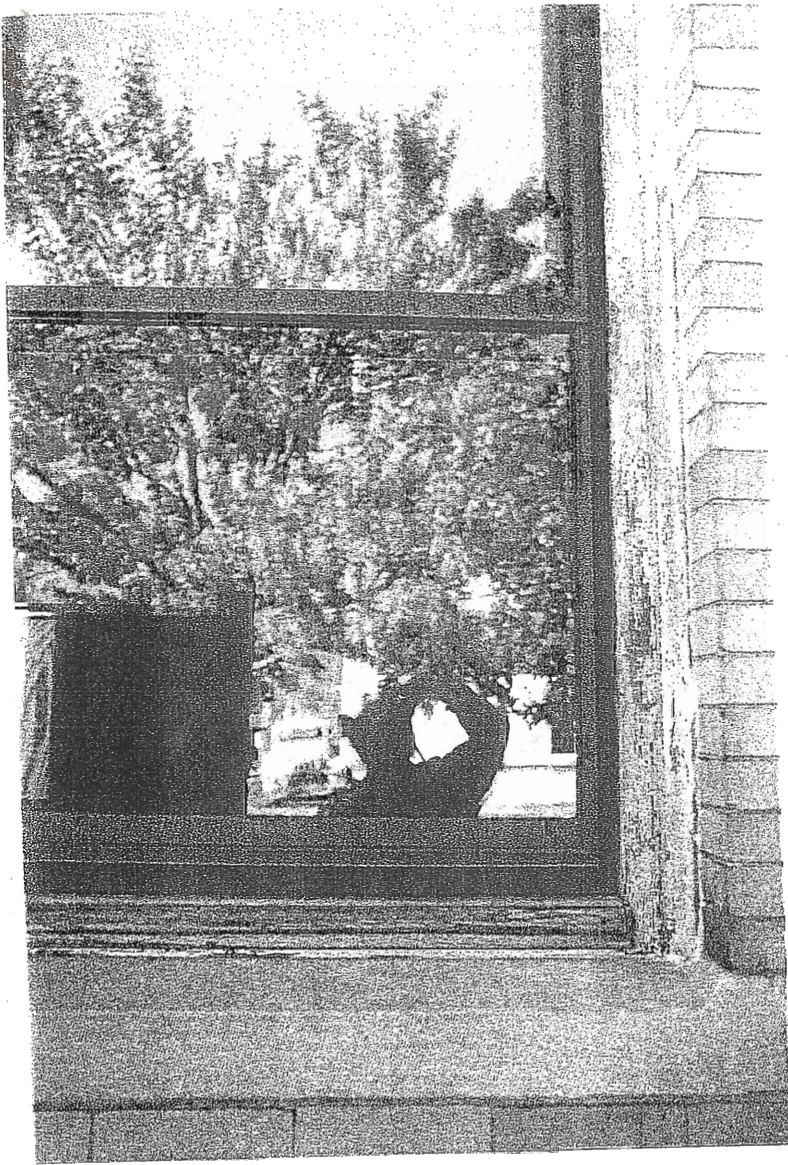
The existing window opening frames surrounding the new window sash are of wood, the paint finish is in poor condition and in need of thorough preparation and painting. The trim in window openings where multiple (3) sash occurs is metal covered, the rust penetrating to the surface is also in need of thorough preparation and rust inhibitive finish.

TYPICAL WINDOW  
NOTE NEW ALUM. SASH  
WOOD FRAMES & TRIM IN  
NEED OF PAINT

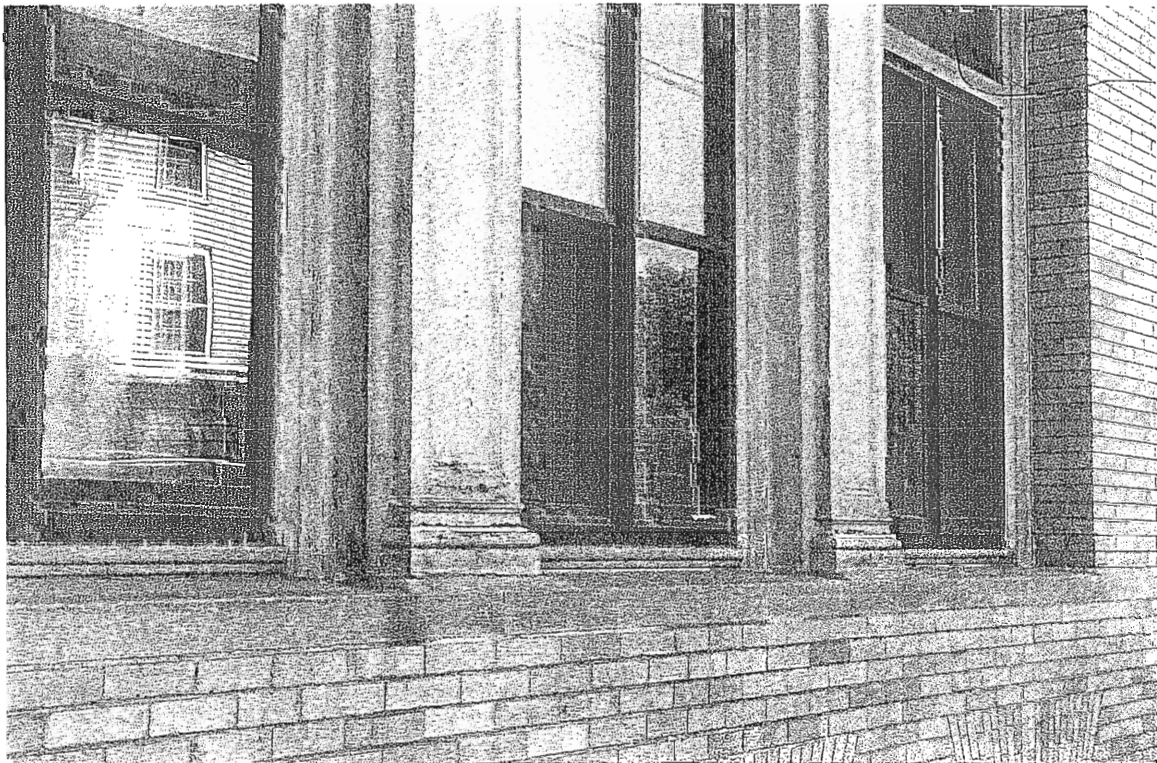
TYPICAL PALLADIAN WINDOW METAL TRIM  
NOTE RUSTING

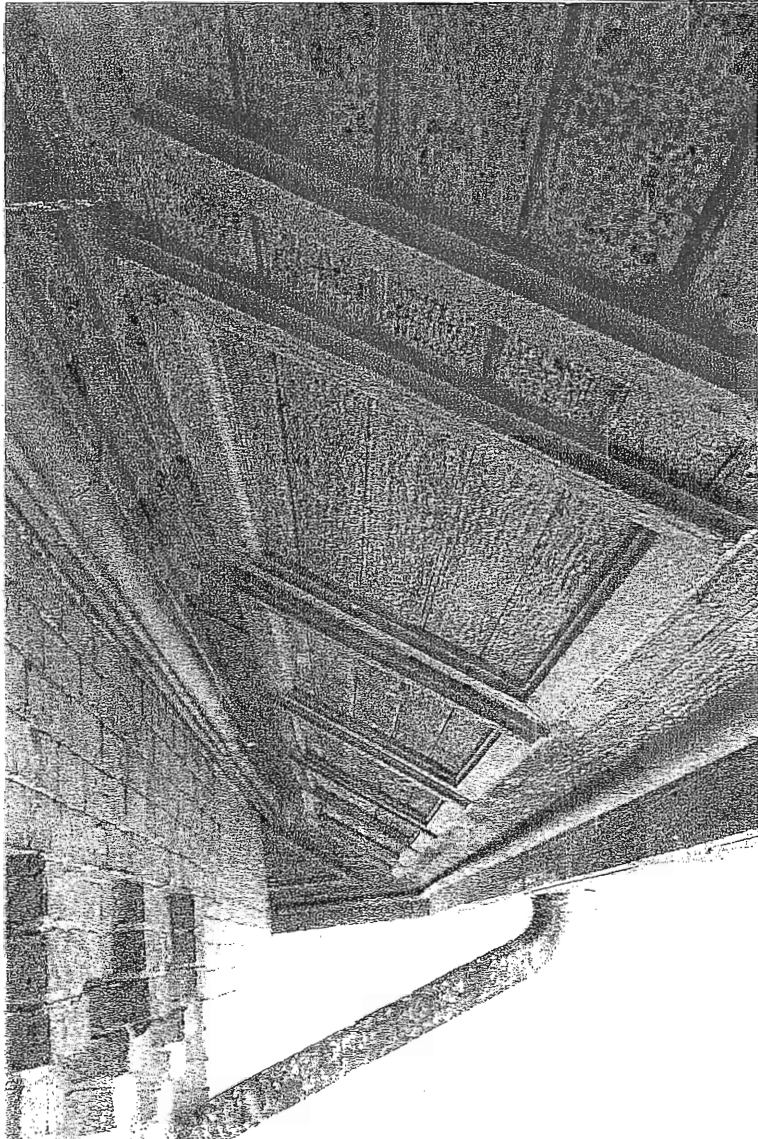
TYPICAL ROOF OVERHANG &  
UNDERSIDE OF SOFFIT -  
NOTE PANEL TRIM AND  
PAINT ALLIGATORING

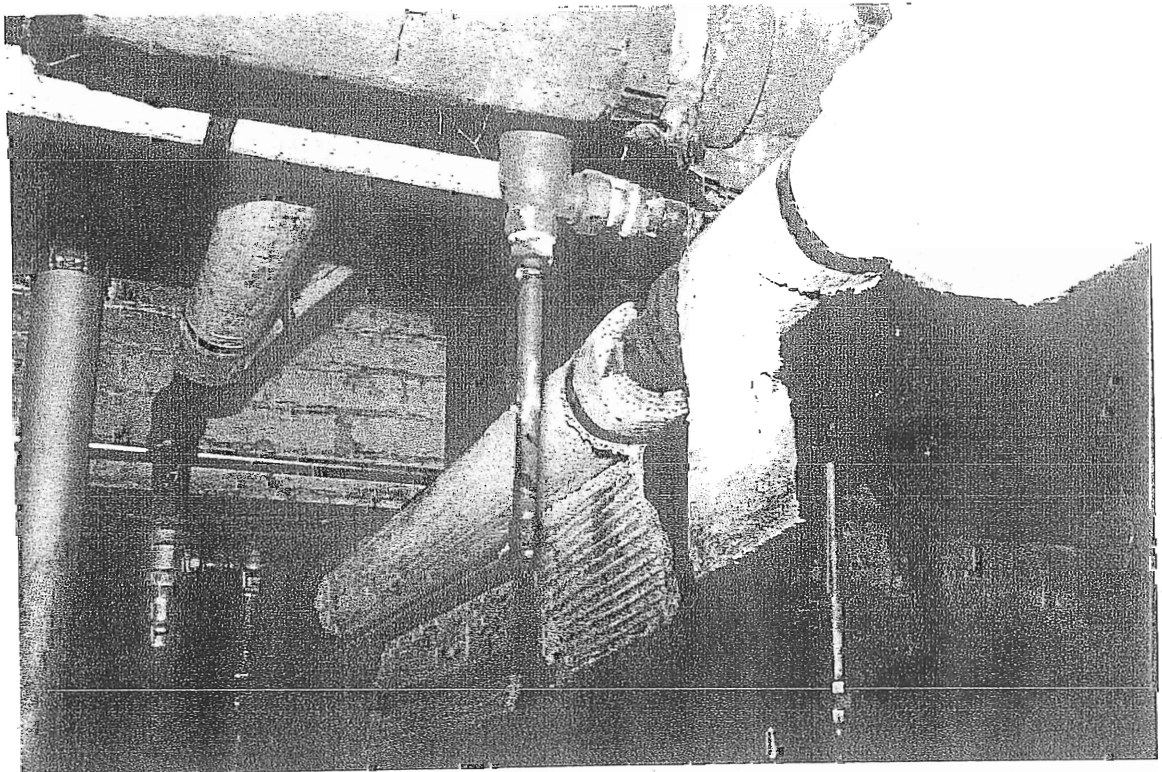
It should be noted that the majority of steaming piping (not the condensate) in the basement is insulated with asbestos containing air cell insulation. The fittings are insulated with asbestos containing mud fittings. This asbestos would have to be abated prior to the removal of the piping. See Photo Page 21.

EXISTING HEATING PIPING -  
NOTE ASBESTOS COVERING
