RENOVATION / RESTORATION
OF THE
TOWN HALL BUILDING
WARREN, MASSACHUSETTS
PART 2

SEPTEMBER 19, 1997

REINHARDT ASSOCIATES, INC.

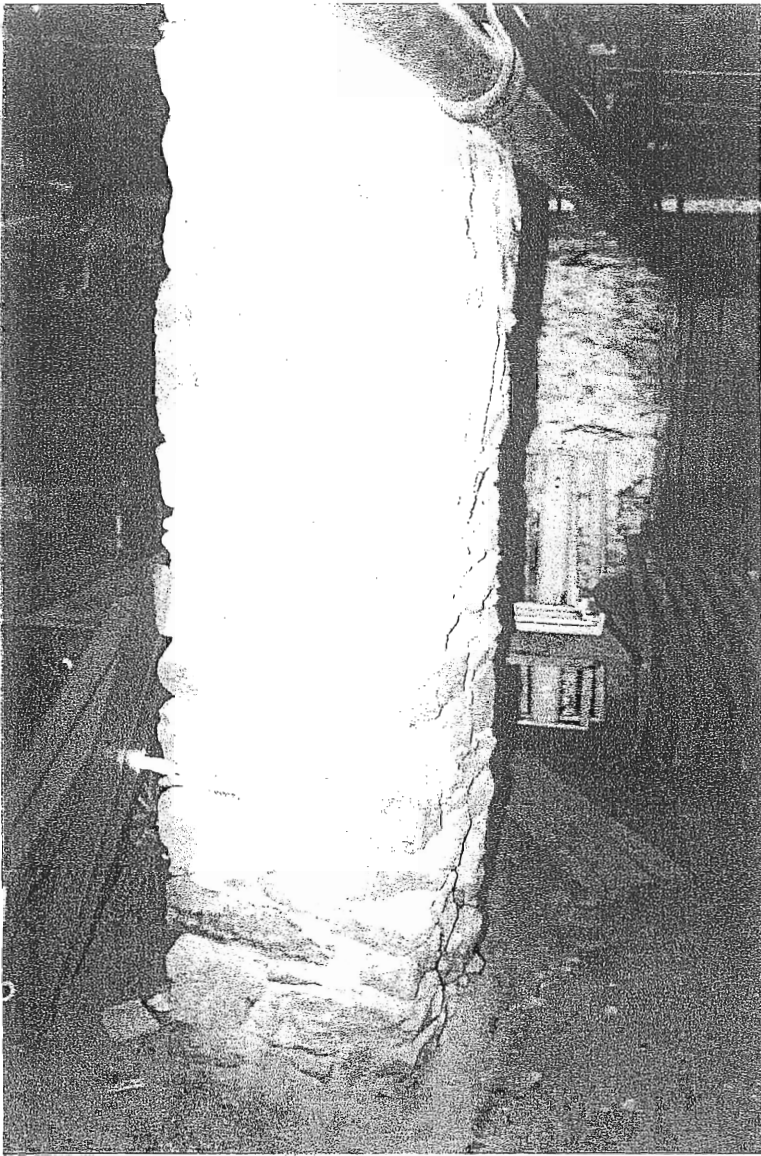
The building rubble stone foundation and the existing interior rubble and interior brick piers of the building are constructed of stone rubble and/or brick mortared in place and with few exceptions appear to be in good condition; the exception being the joints in the lower twelve (12) to eighteen (18) inches of the brick piers are in need of pointing due to moisture absorption and its affect on the brick and mortar. Refer to Part 2, Photo Pages 25 and 26.

TYPICAL RUBBLE STONE PIER

DUST TYPE MATERIAL AT BASE
OF RUBBLE AND/OR BRICK PIER
INDICATES MORTAR LOOSENING
DROPPING

Although not immediately affecting the structural integrity of the rubble stone piers and brick piers, in order to prevent future deterioration it is recommended that the joints in the brick and/or rubble stone piers in the lower twelve (12) to eighteen (18) inches of the piers, where mortar is deteriorating, be pointed.

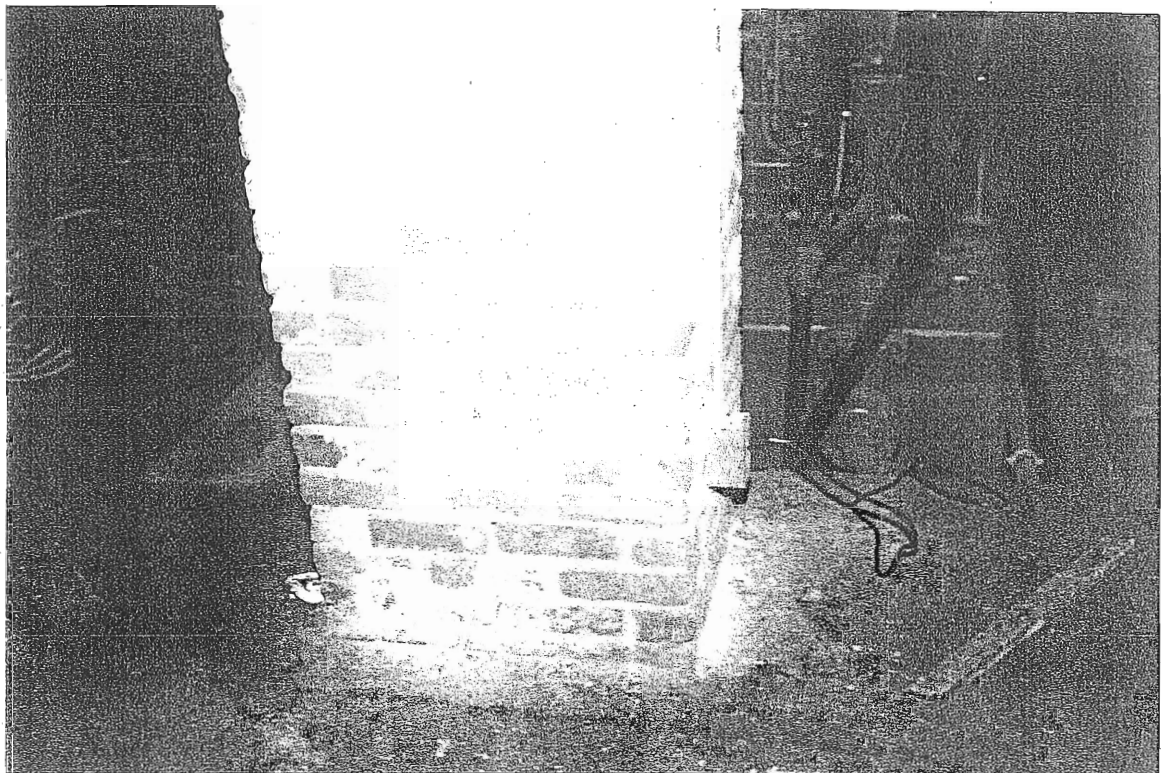
TYPICAL BRICK PIER

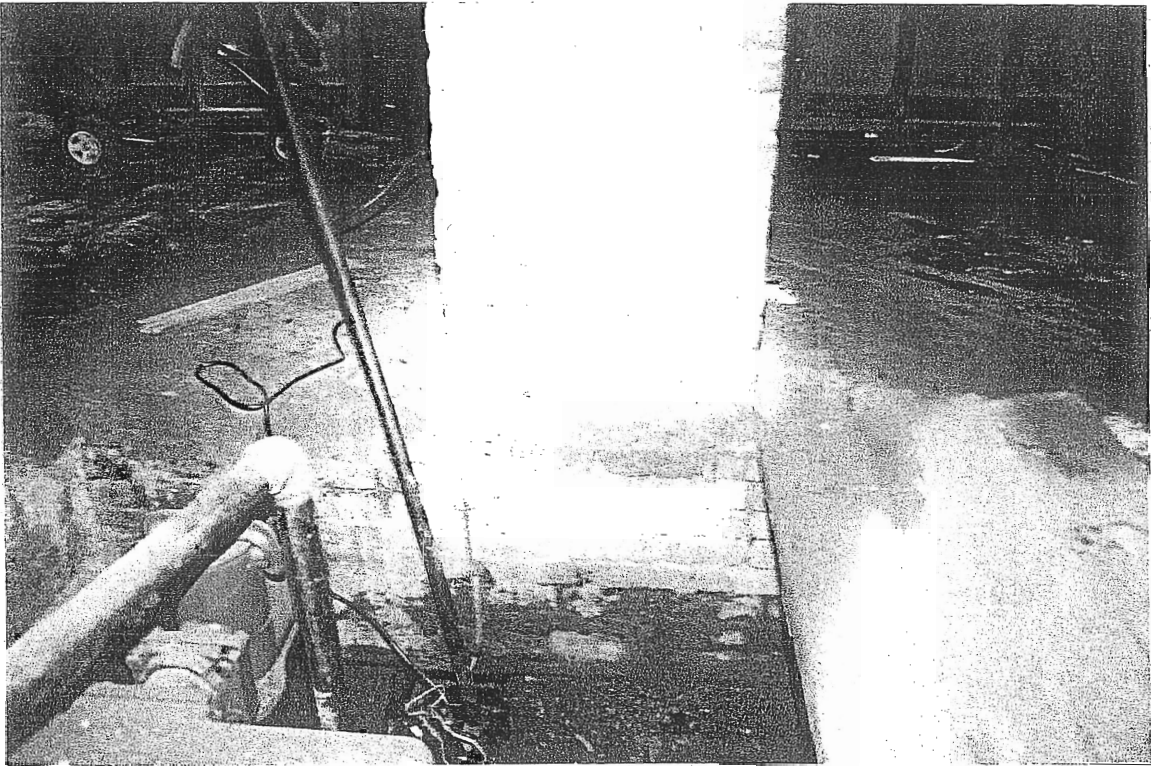
BRICK PIER @ EDGE OF BOILER PIT

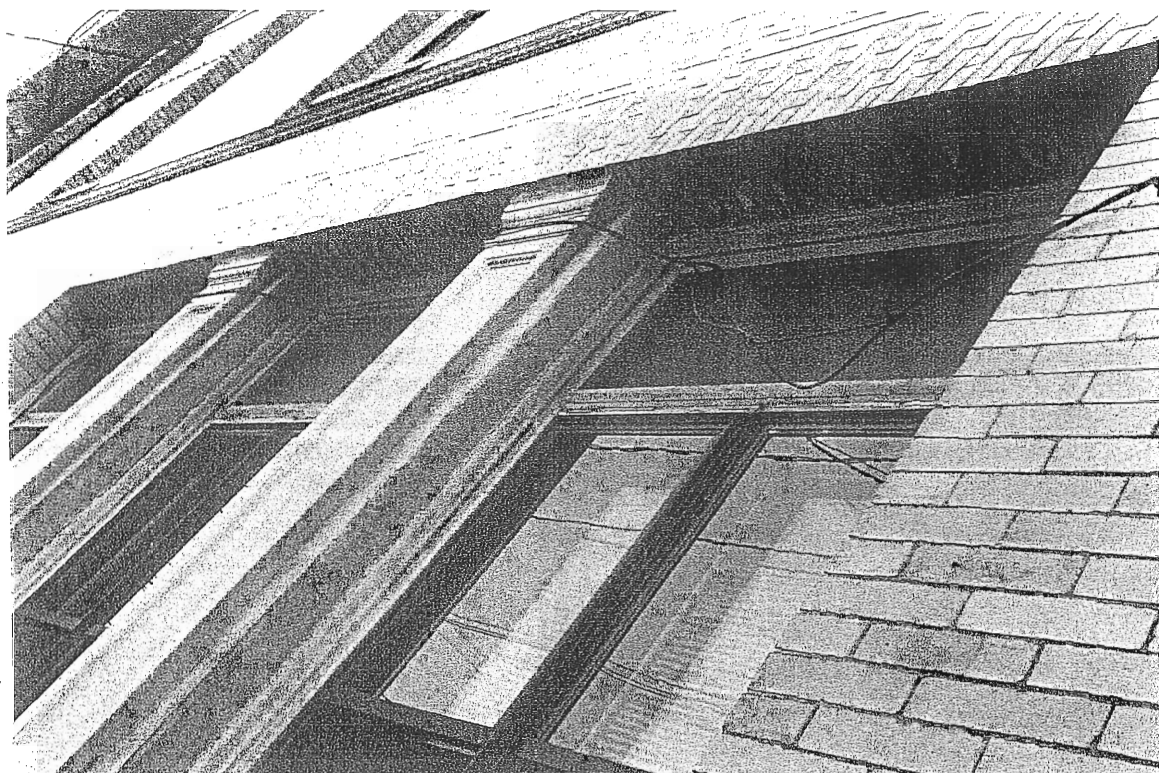
TYPICAL PALLADIAN WINDOWS MAIN ST. SIDE - NOTE RUSTING
COMING TO SURFACE AT PILASTER SIDES

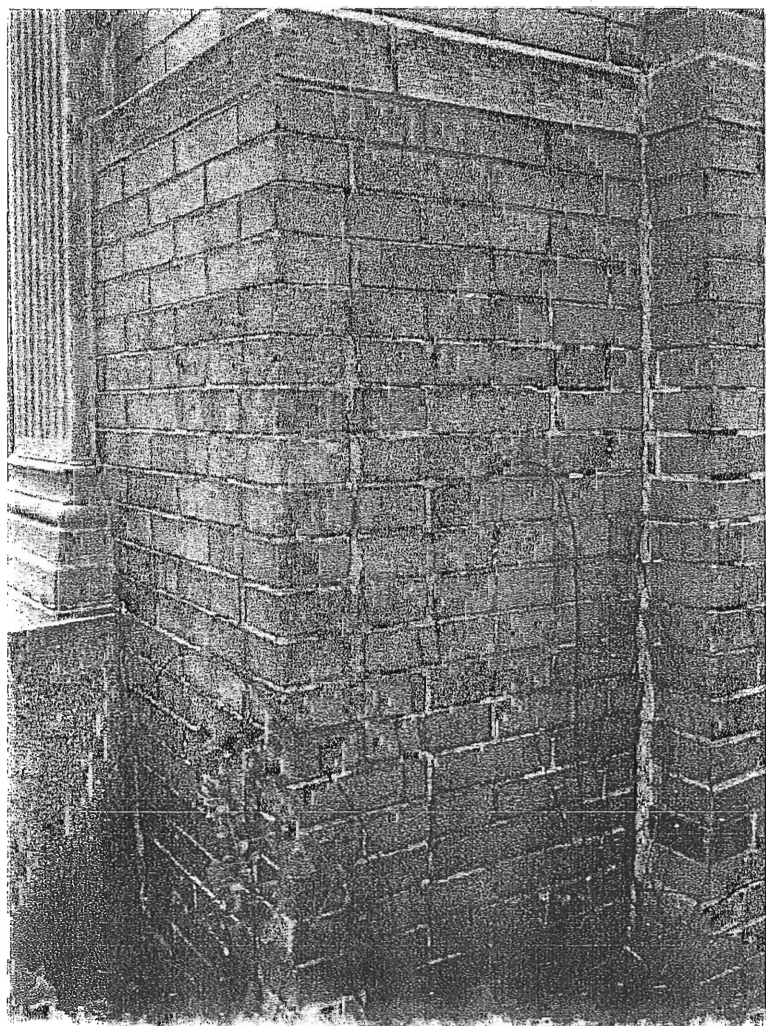
The brick on the North (Main Street) side from the Northeast corner, the general base of the Clock Tower, an area of approximately sixteen (16) to eighteen (18) feet long by ten (10) feet high is cracked, and joints are lacking mortar in many places. The precise cause of crack in the brick in this area are indeterminate - the reasons extending into the past and being contributed to may possibilities such as past seismic causes, movement of the Clock tower structure relative to the building structure; settlement of the Clock Tower structure; all in possible combination with entrance of moisture and freeze/thaw conditions.

NORTHEAST CORNER OF
CLOCK TOWER (START OF
LIMESTONE ARCHED ENTRY
@ LEFT)

It is recommended that in order to limit further deterioration that the cracked brick be replaced with new brick to match existing and all open joints be thoroughly raked and pointed. It is also recommended that the belt course be given particular attention and it's horizontal and vertical joints be thoroughly pointed and caulked. Saw cutting vertical joints in one or two locations may also possible lend to the relief of certain stresses and reduce and/or eliminate further brick cracking/breaking in this area of the wall.

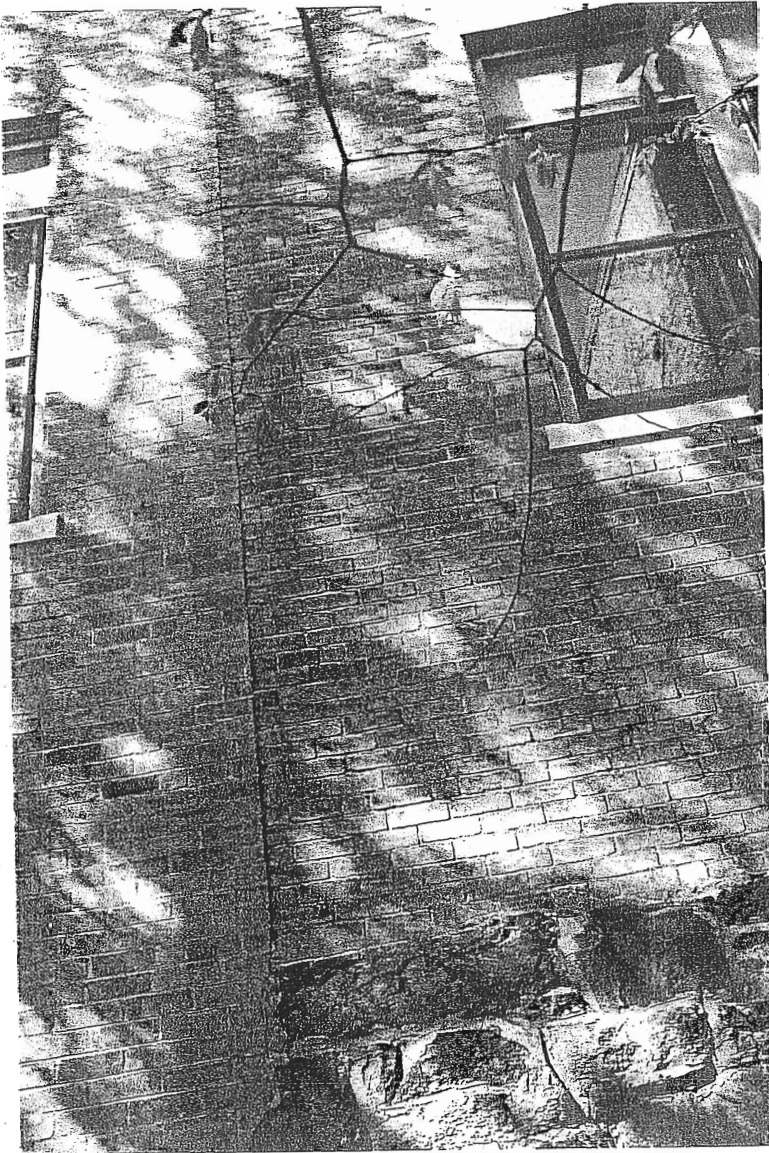
On the South (Powder Mill Brook) side of the Building certain areas of brick joints have deteriorated and need pointing. Approximately 30% of the brick area between the fourth pilaster (from the S.E. corner and the chimney needs pointing). Also 20% of the area of the south wall west of the existing chimney is in need of pointing. The brick joint between the original building and the Memorial Hall/Stage Addition is now open to weather and requires new caulking/sealant. Refer to Part 2, Photo Page 28.

SOUTH SIDE OF BUILDING
WHERE WEST ADDITION ABUTS
ORIGINAL BUILDING - NOTE
JOINTS NEEDING POINTING
ALSO VERTICAL JOINT OPEN TO
WEATHER

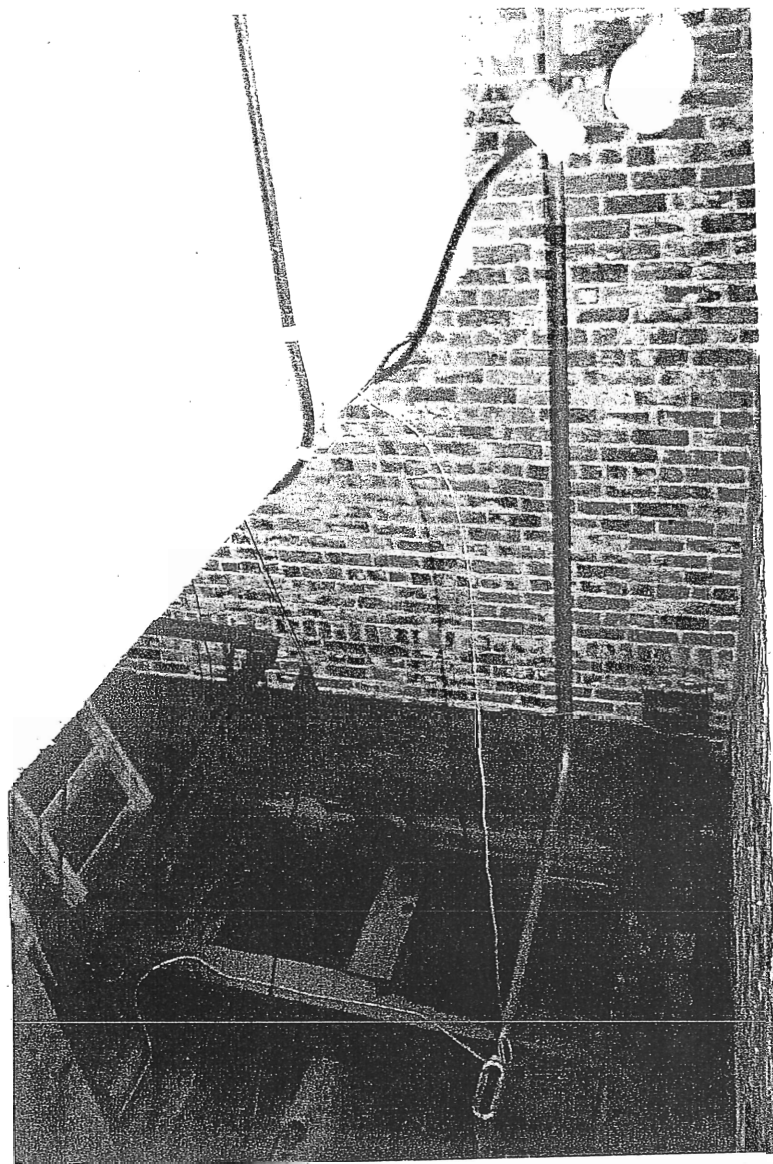
CLOCK TOWER INTERIOR

CLOCK WORKS ENCLOSURE @
LOWER RIGHT UNDERSIDE OF
BELL LEVEL WOOD FLOOR &
BEAMS AT TOP AND LADDER
LEADING TO SAME AT UPPER
RIGHT

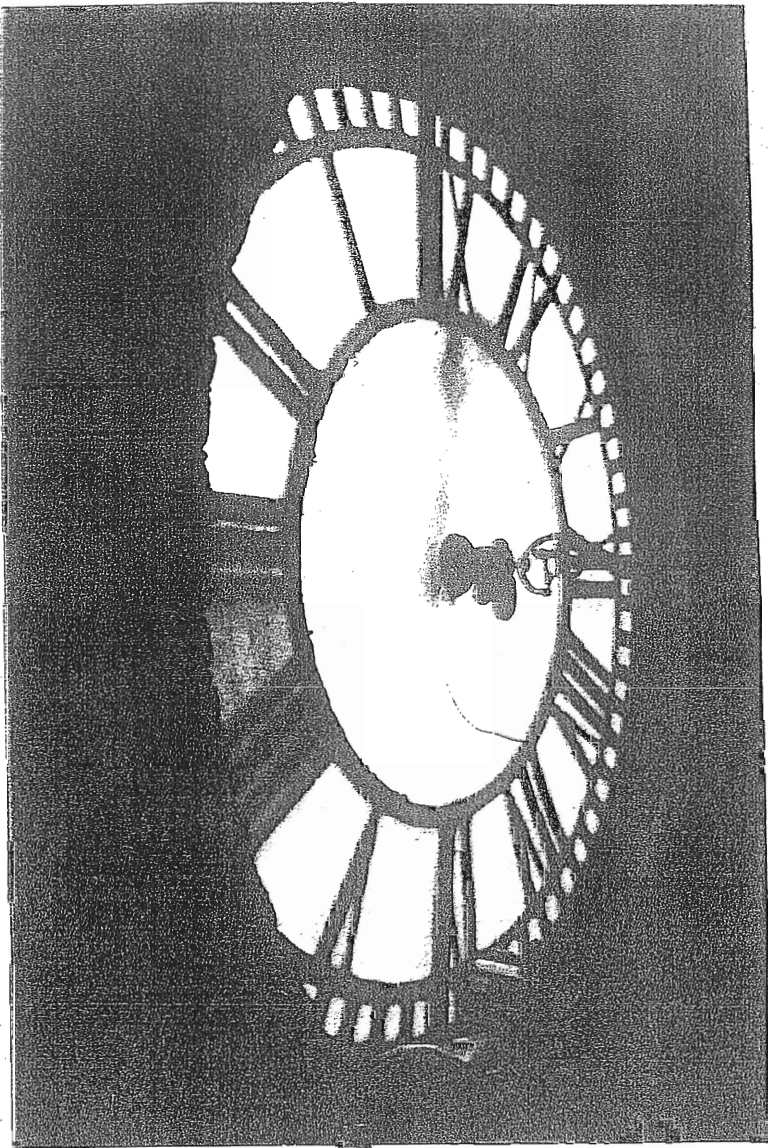
The glass clock face on the West side is cracked and in need of replacement and is recommended. General cleaning and removal of debris is necessary at the clock works level. Exposed brick walls in these areas appear to be in good condition. Refer to Part 2, Photo Page 30.

CLOCK FACE
FROM INTERIOR &
EXTERIOR NOTE CRACKED
FACE

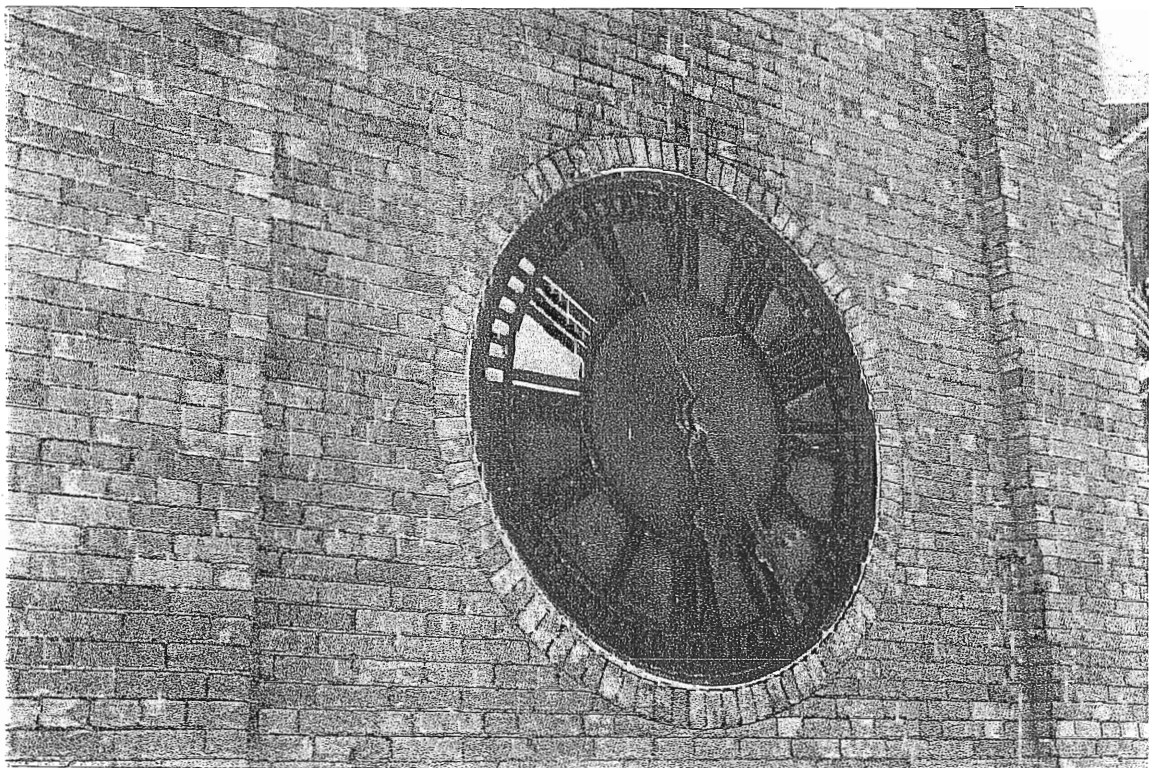
CRACKED CLOCK FACE FROM EXTERIOR

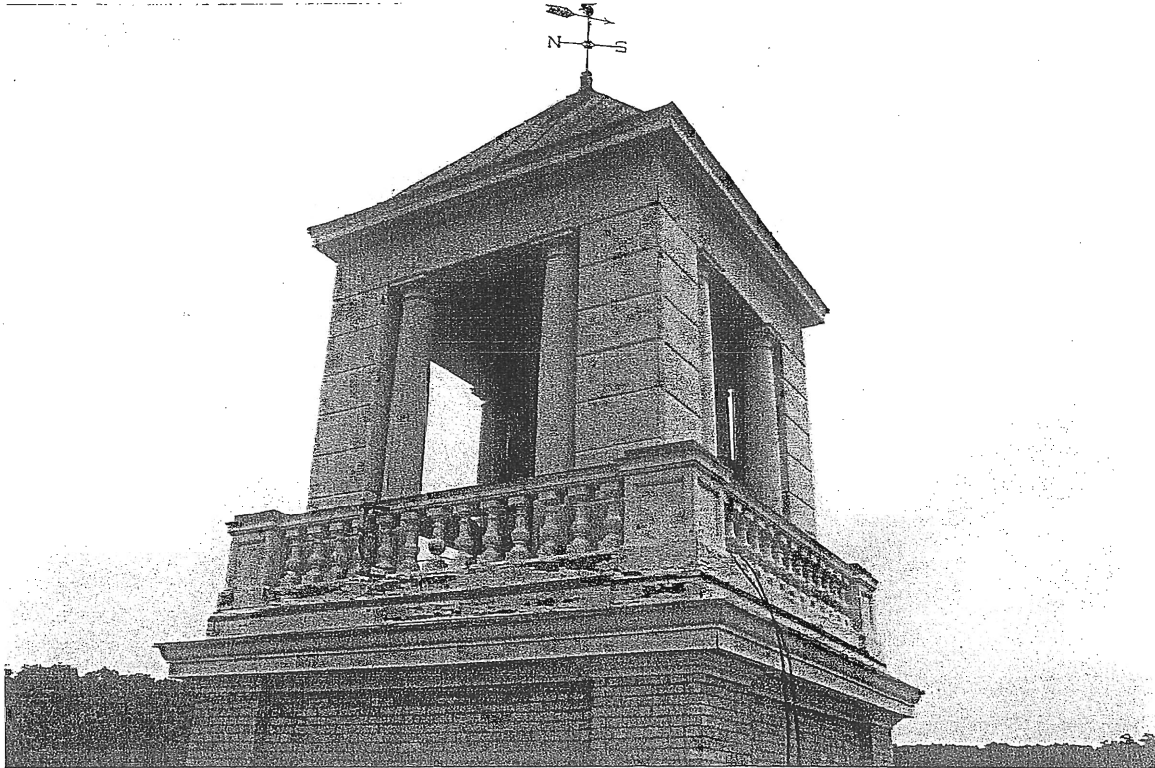
The wood pilasters, quoins, columns, rail and rail balusters, as well as the cornice trim are in a deteriorating condition resulting in cracks, splits and shrinkage due to age, lengthy exposure to weather and lack of maintenance. Refer to Part 1, Photo Pages 9 and 10 and Part 2, Photo Page 31. These items are in need of reconditioning and/or repair and/or replacement at the present. The life expectancy of these items is believed to be quite limited if corrective work of some kind does not take place in the near future.

**OPEN BELL LEVEL FROM ROOF OF BUILDING
NOTE DETERIORATING PAINT CONDITION**

It is recommended that, where feasible and without historic conflict, the use of more permanent materials be considered for replacements, that aluminum cladding of simpler wood components be utilized and that a specific maintenance schedule be established inasmuch as the location of these items lends to neglect of their scrutinization.

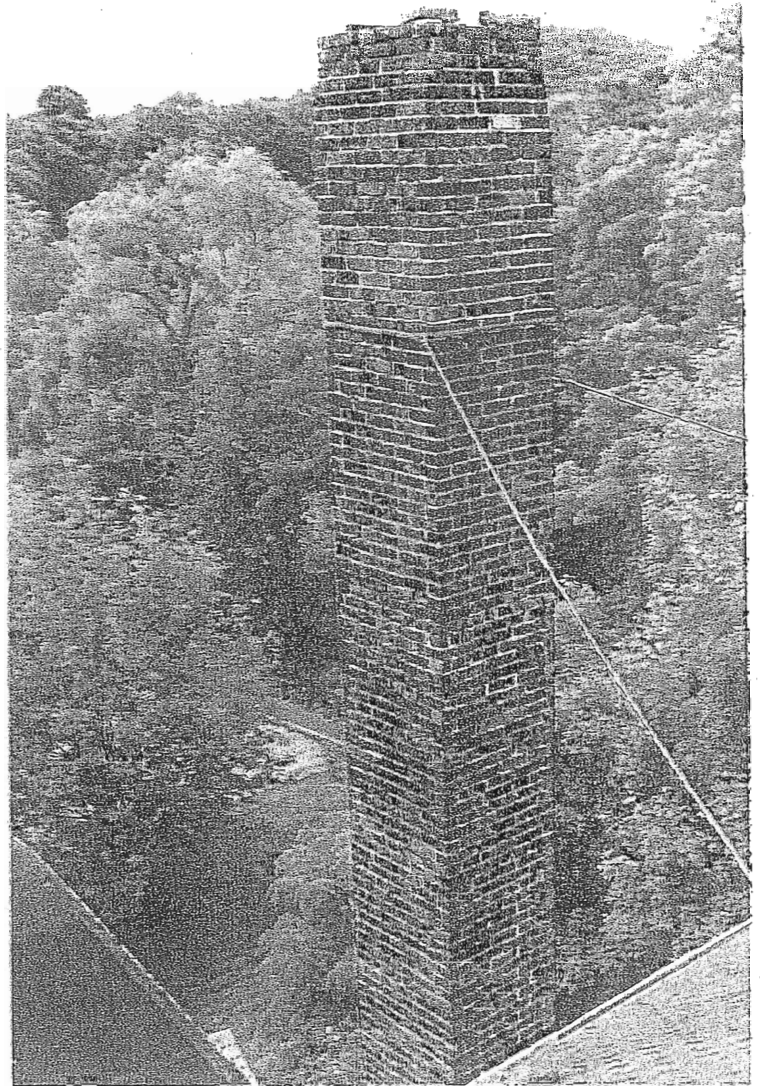
Refer to Part 2 - Photo Page 33. The existing chimney is approximately 32" square of brick rising from the foundations to approximately twenty-four (24'-0") above the eaves of the building. The top of the chimney terminates with brick of the same type as the body of the chimney with no cap of any kind for protection of the brick. Some of the brick of the uppermost course are missing and some are loose; the top few brick course joints are nearly mortarless, open to weather and consequent cold weather freeze/thaw cycle resulting in continuing deterioration of the chimney top. The loose brick are a danger should weather or wind be the cause of their dropping off and bringing about serious injury or worse to someone in the vicinity.

EXISTING CHIMNEY LOOKING SOUTH
FROM ROOF - NOTE LOOSE BRICK @
TOP COURSE

The immediate priority regarding the chimney is to provide the necessary repair to the uppermost area of the chimney, provide a new cap and pointing the joints in the uppermost extremity of the chimney.

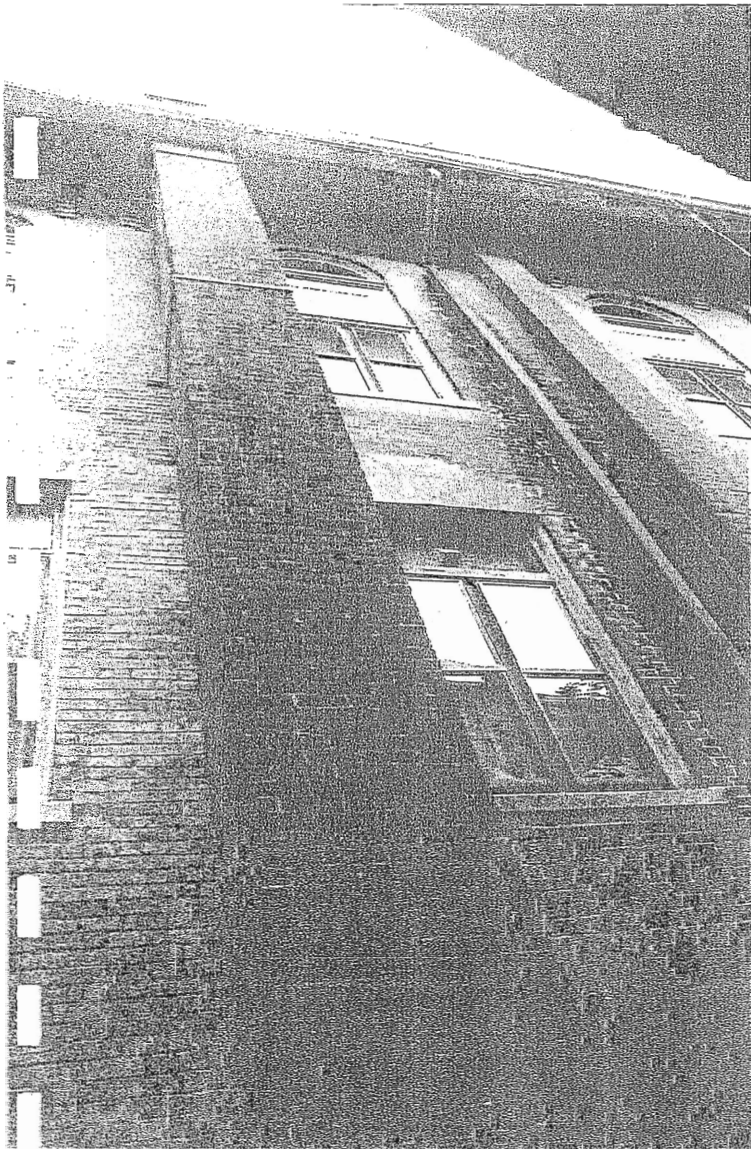
EXISTING CHIMNEY LOOKING
UP FROM GRADE

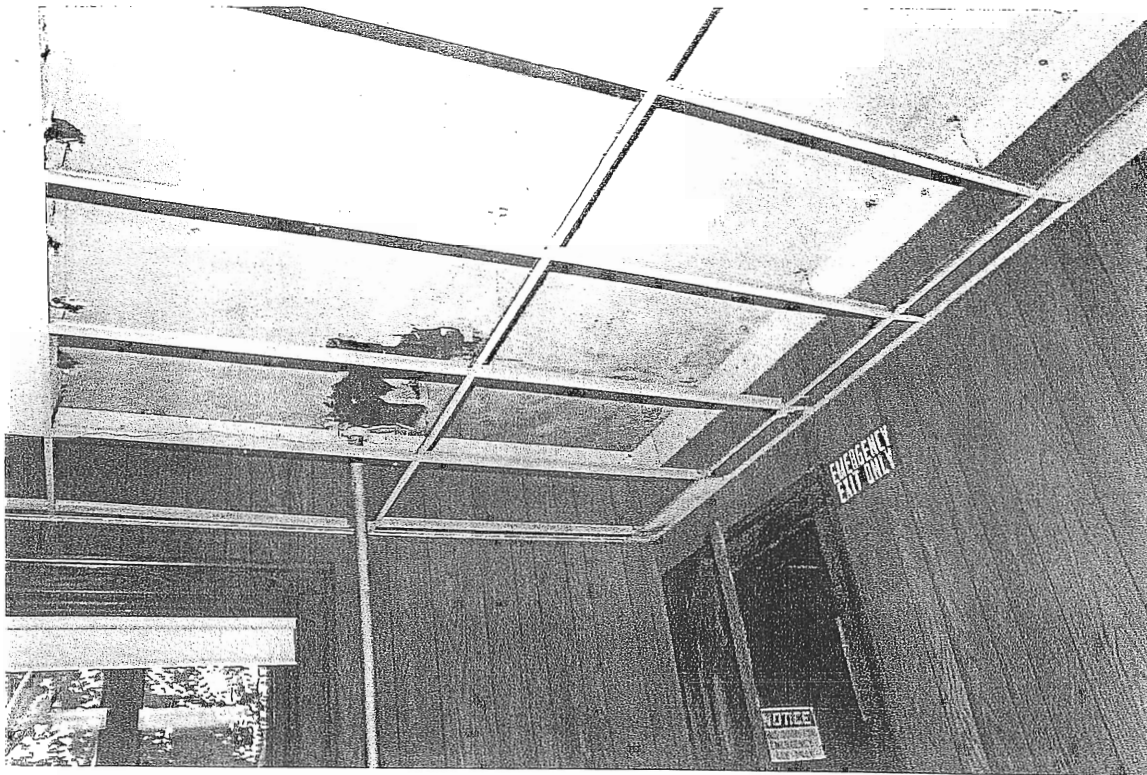
**MEMORIAL HALL - PARTLY DISMANTLED ACOUSTIC CEILING
EXISTING - DAMAGED PLASTER CEILING ABOVE**

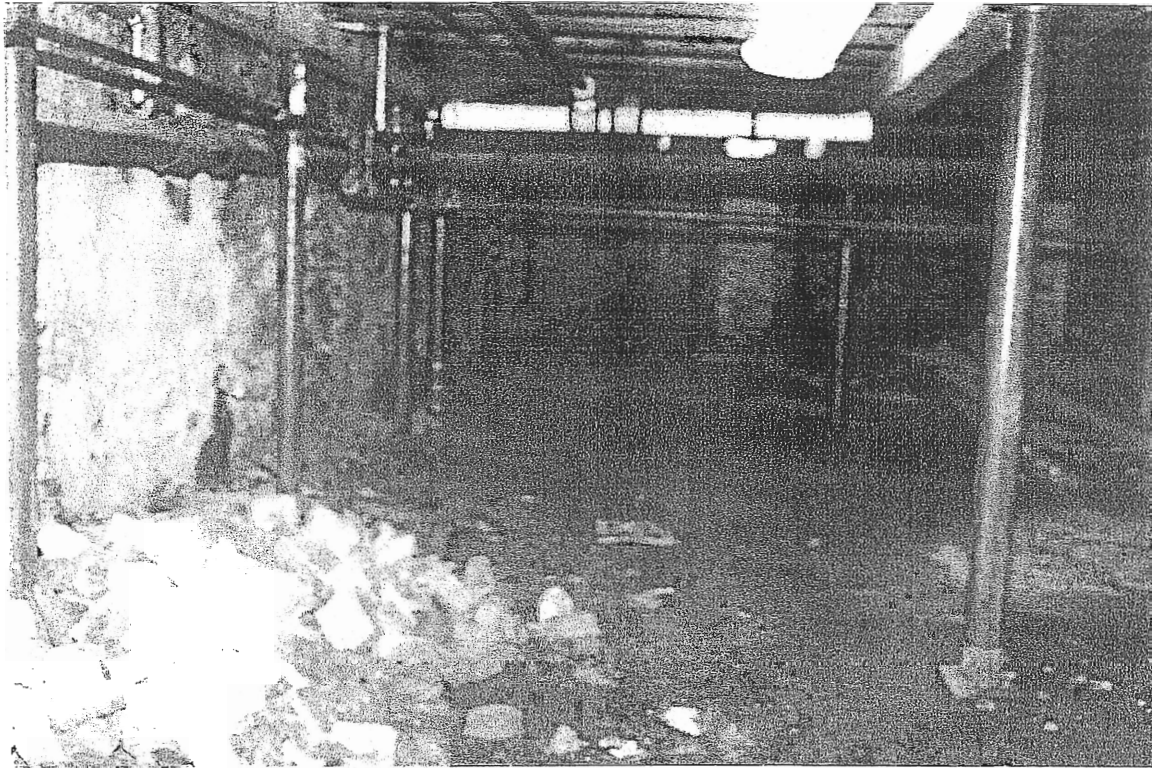
**LOW HEAD ROOM (CRAWL) SPACE UNDER MEMORIAL HALL
LOOKING NORTH - NOTE ADDITIONAL FLOOR SUPPORT BEAMS AND COLUMNS**

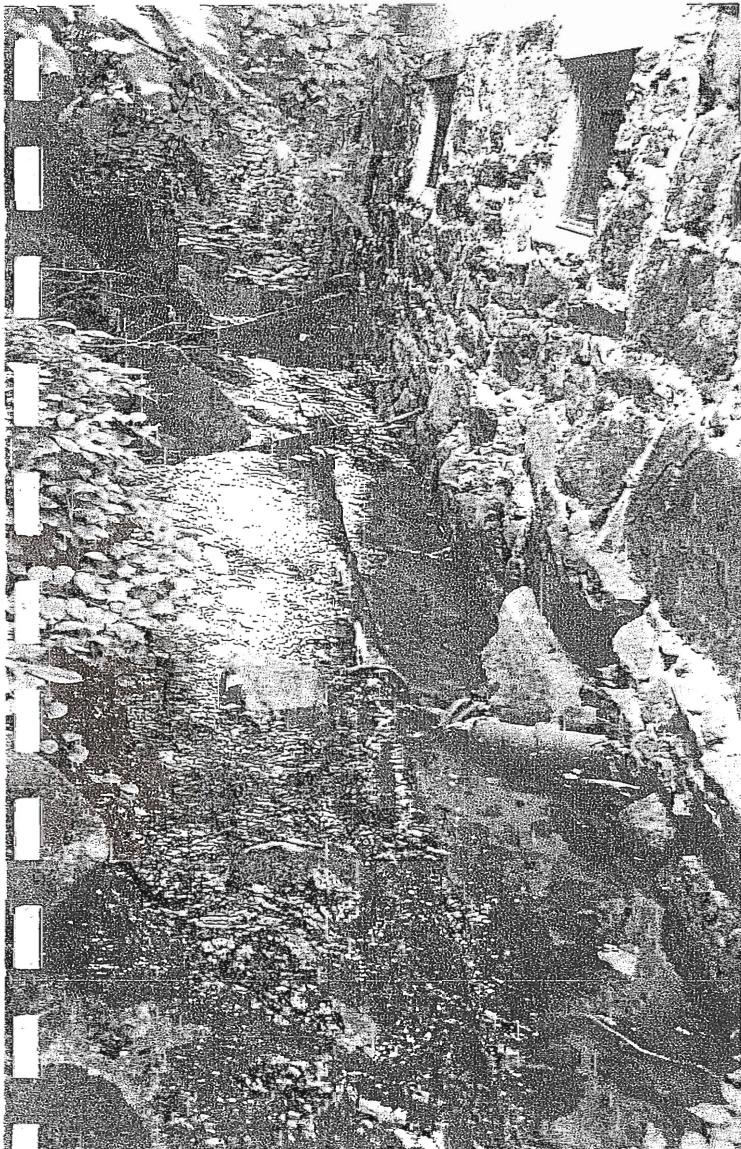
EXPOSED SOUTH SIDE RUBBLE
FOUNDATION WALL ADJACENT
TO POWDER MILL BROOK
LOOKING WEST

LOW LEVEL OF STREAM WATER
EXPOSES EXISTING SEWER LINE
