# STUDY

RENOVATION / RESTORATION  
OF THE  
TOWN HALL BUILDING  
WARREN, MASSACHUSETTS

JULY 25, 1997

REINHARDT ASSOCIATES, INC.

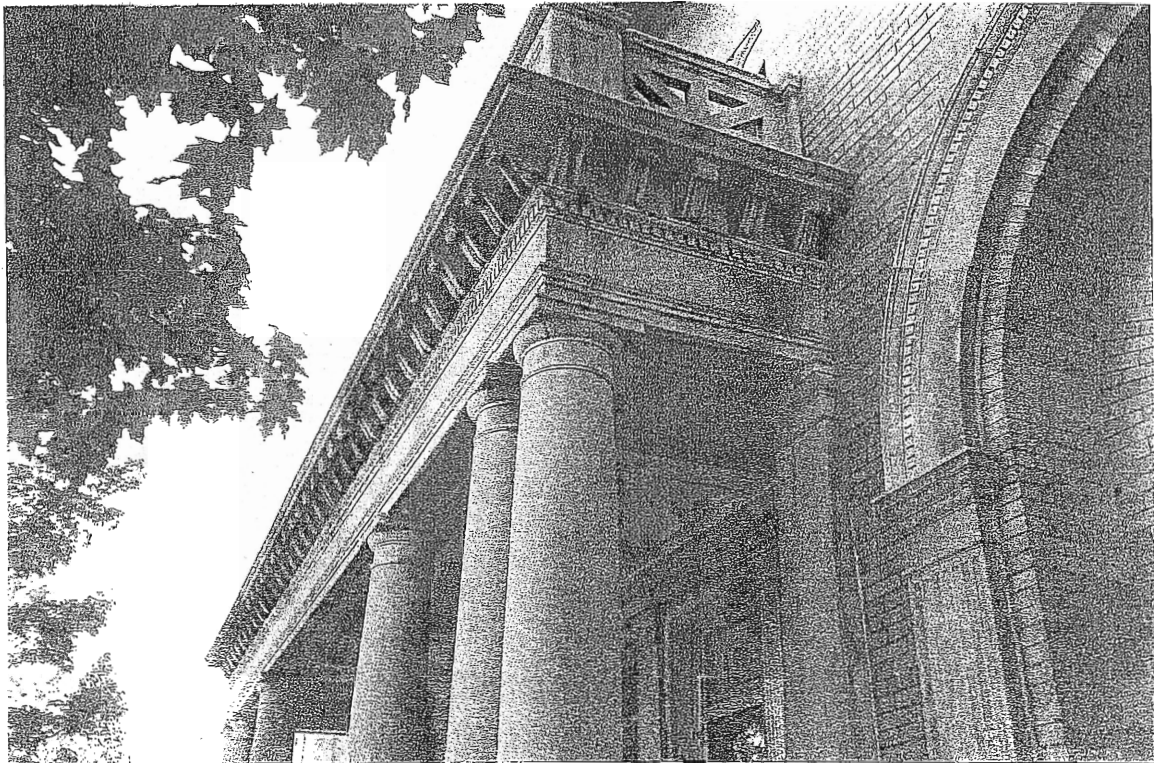
The front entrance Portico is roofed with built-up tar and gravel whose life expectancy has generally been expended and is in need of replacement. Refer to Photo Page 4.

**WARREN TOWN HALL  
FRONT ENTRANCE PORTICO DETAIL**

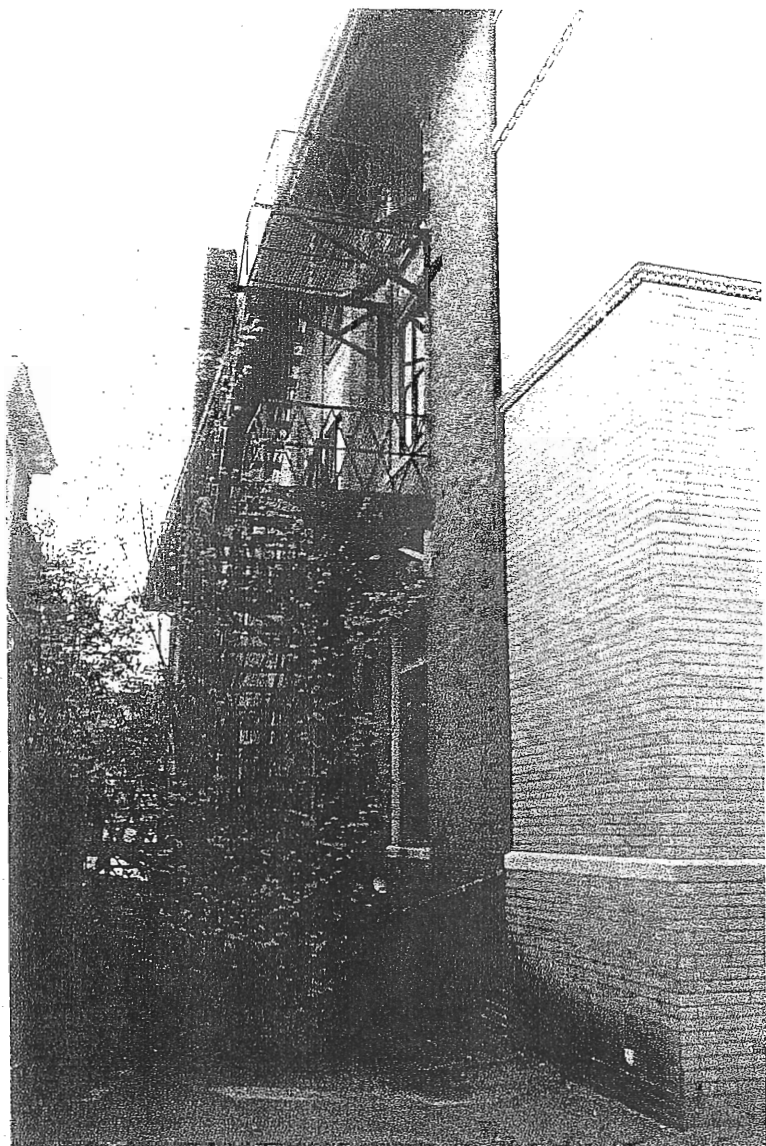
On the South (Powder Mill Brook) side certain areas of brick joints have deteriorated and need repointing. The Southwest area beyond the chimney also needs repointing work. The brick joint between the original building and the Memorial Hall/Stage Addition is now open to weather and requires new caulking/sealant.

WARREN TOWN HALL  
LEFT (SOUTH) SIDE

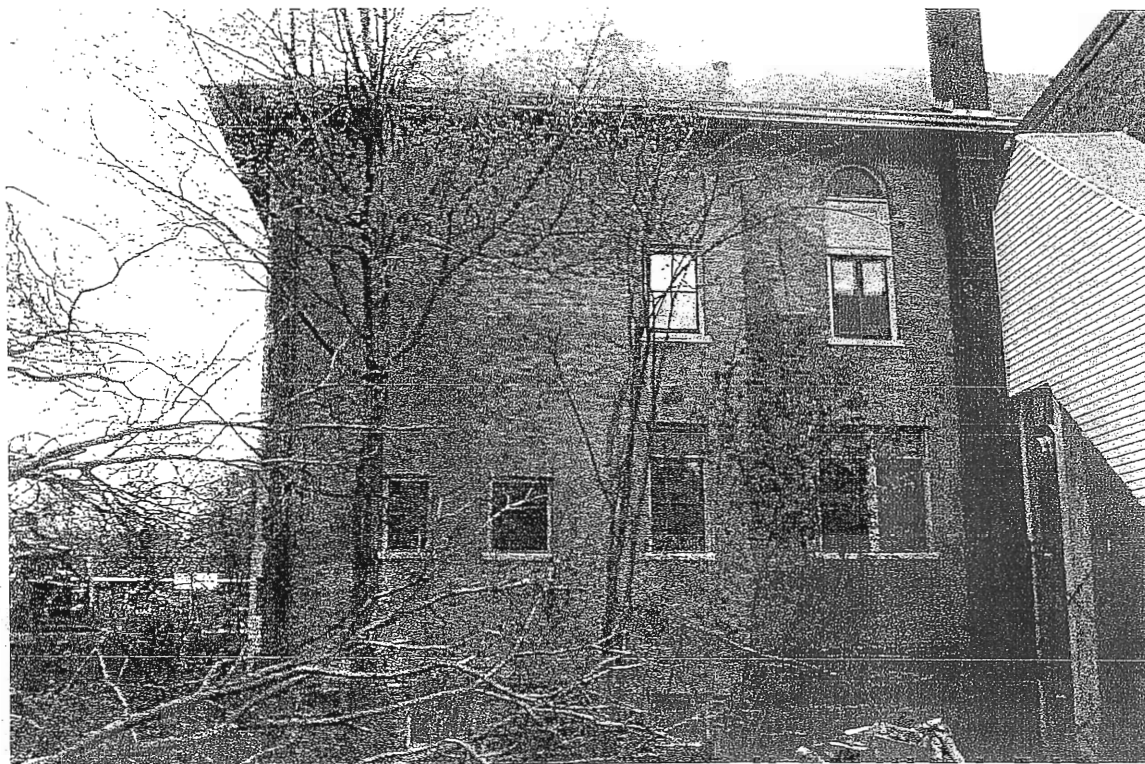
The West (rear) of the building shows evidence of diagonal cracks in two locations which have been repaired. Further investigation may be needed to determine the reason for this cracking.

WARREN TOWN HALL  
REAR (WEST) SIDE

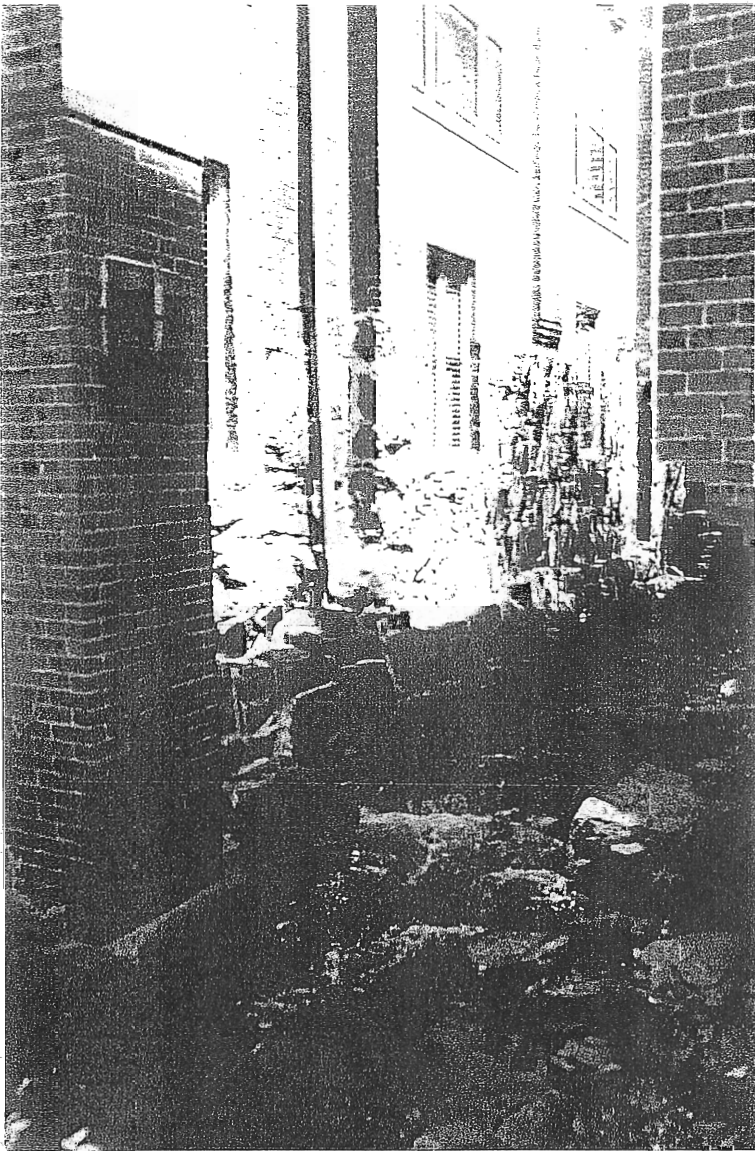
WARREN TOWN HALL  
SOUTH SIDE  
EXPOSED FOUNDATION  
WALL WASHED BY BROOK  
LOOKING FROM REAR  
(SOUTHWEST)

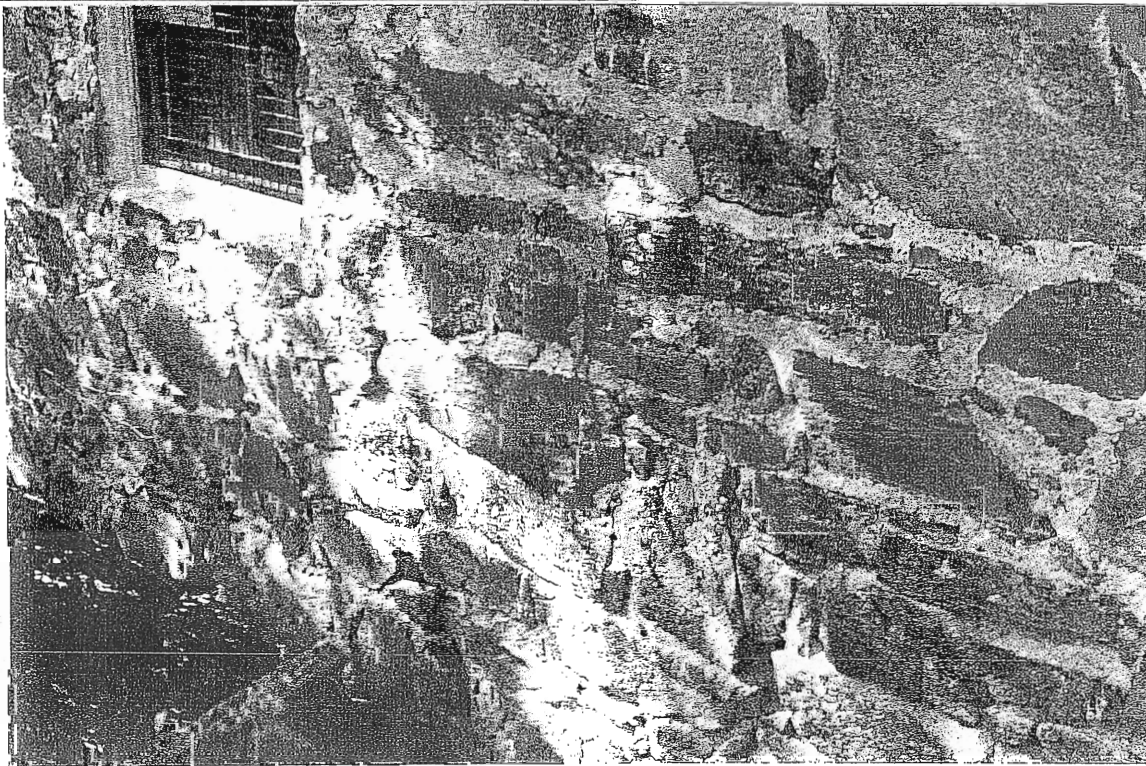
The sealing of the brick of the Addition on the South (Powder Mill Brook) side would add to the life of the mortar joints. The exterior of the rubble stone foundations of the Memorial Hall/Stage Addition requires mortar repointing in some areas. Except as described in previous paragraphs the hard-faced brick with narrow joints do not appear to need sealing. Also refer to Building interiors.

WARREN TOWN HALL  
EXPOSED RUBBLE FOUNDATION WALL (SOUTH SIDE)

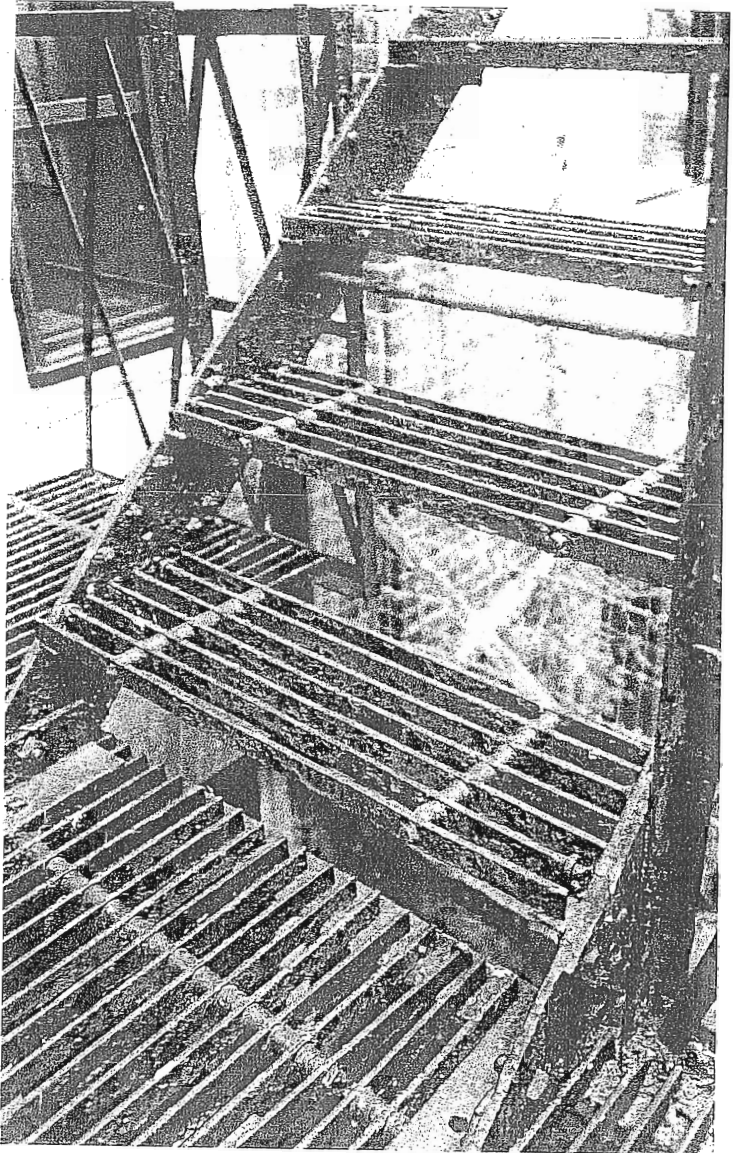
The existing fire escape which serves as the secondary exit stair from the Balcony to the exterior grade appears to be structurally sound, nevertheless the lack of maintenance, primarily the absence of thorough scraping and painting of the steel members is resulting in rust and deterioration which weakens structural components. The determination of the final use or non-use of the fire escape stairs may rest with decisions later made as to the further use or non-use of the balcony or later decision made regarding the use or function of the building. This does not preclude the necessity of much needed maintenance in the form of scraping and painting at the present time. See Photo Page 7.

FIRE ESCAPE -  
LEADING FROM BALCONY  
TO GRADE  
(NOTE RUSTING CONDITION)

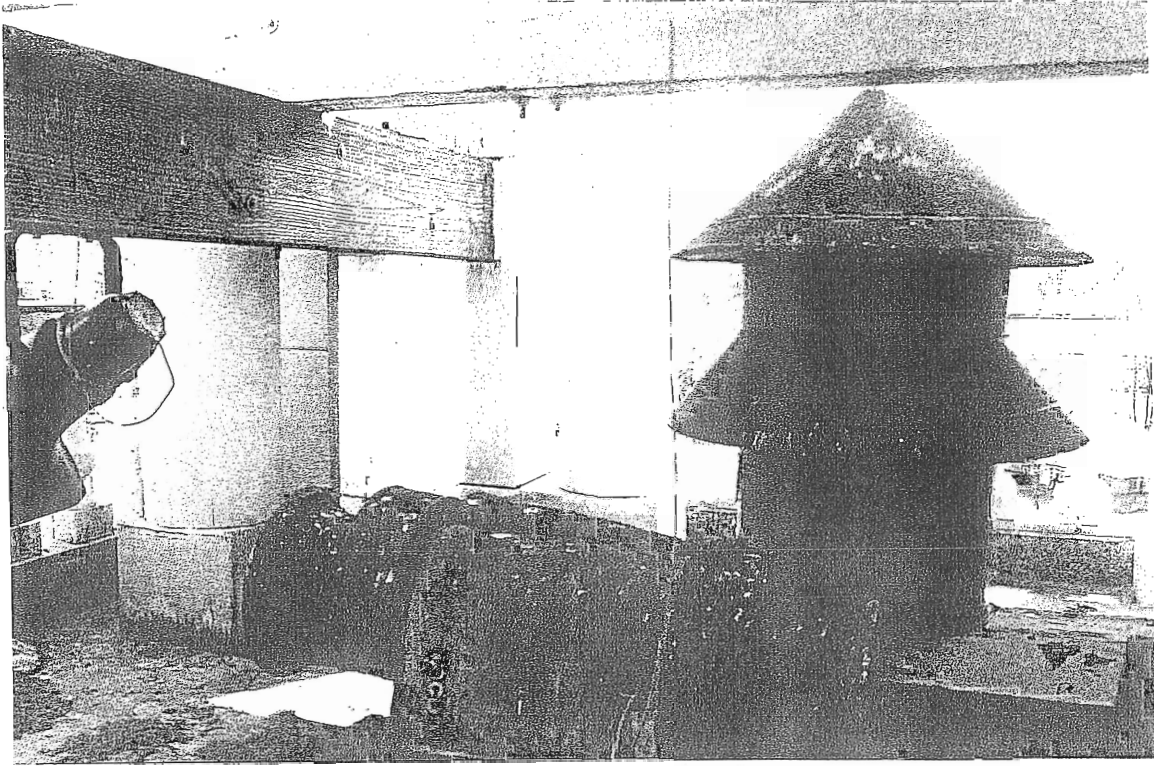
**OPEN BELL LEVEL  
(NOTE SUPPORT STRUCTURE & SPEAKER LEFT)**

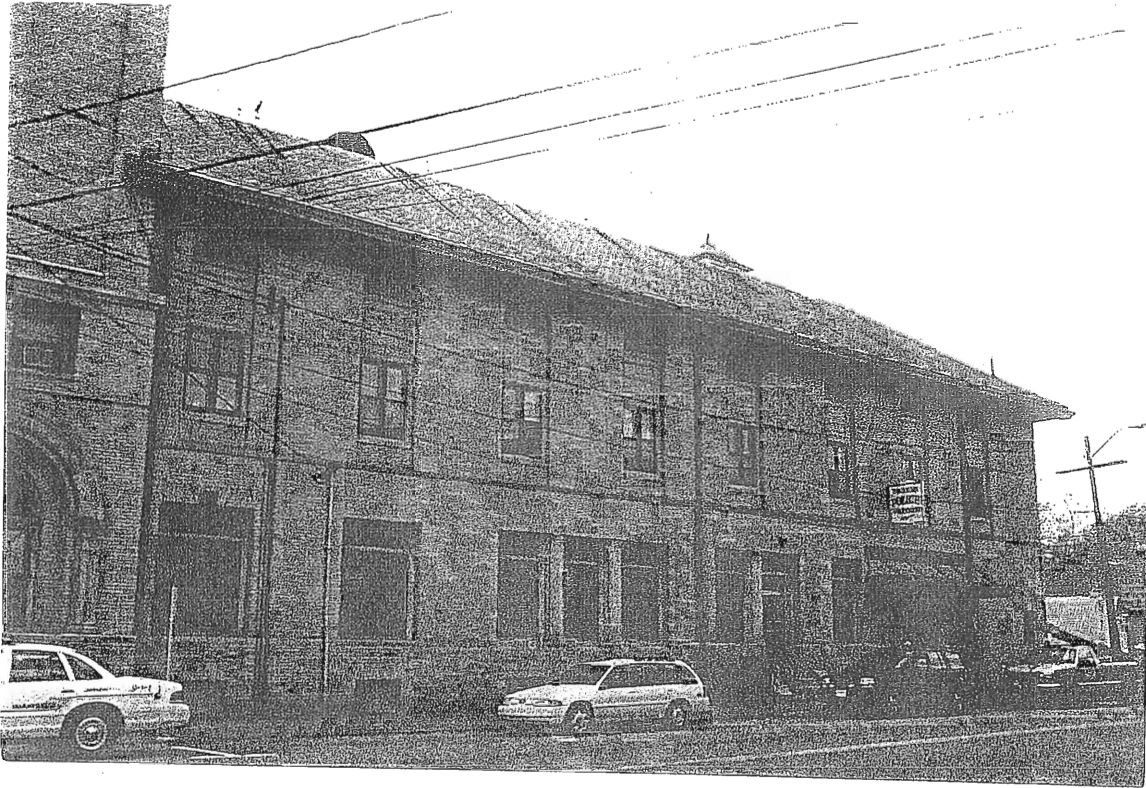
The flat area of the roof is a smooth surface built-up roofing in poor condition and in need of replacement, with little, if any life expectancy. The sloped area of the roof is roofed with slate shingles in poor condition and in need of repair. Without repair this roof life expectancy is estimated at five years at which time some definite measures of repair and/or replacement will be necessary. Repair of the built-up roof in the near future should extend the life expectancy of the roof to thirty years and the slate roof to sixty years.

**SLOPED (MAIN STREET) SIDE OF  
ROOF WITH SLATE SHINGLES**

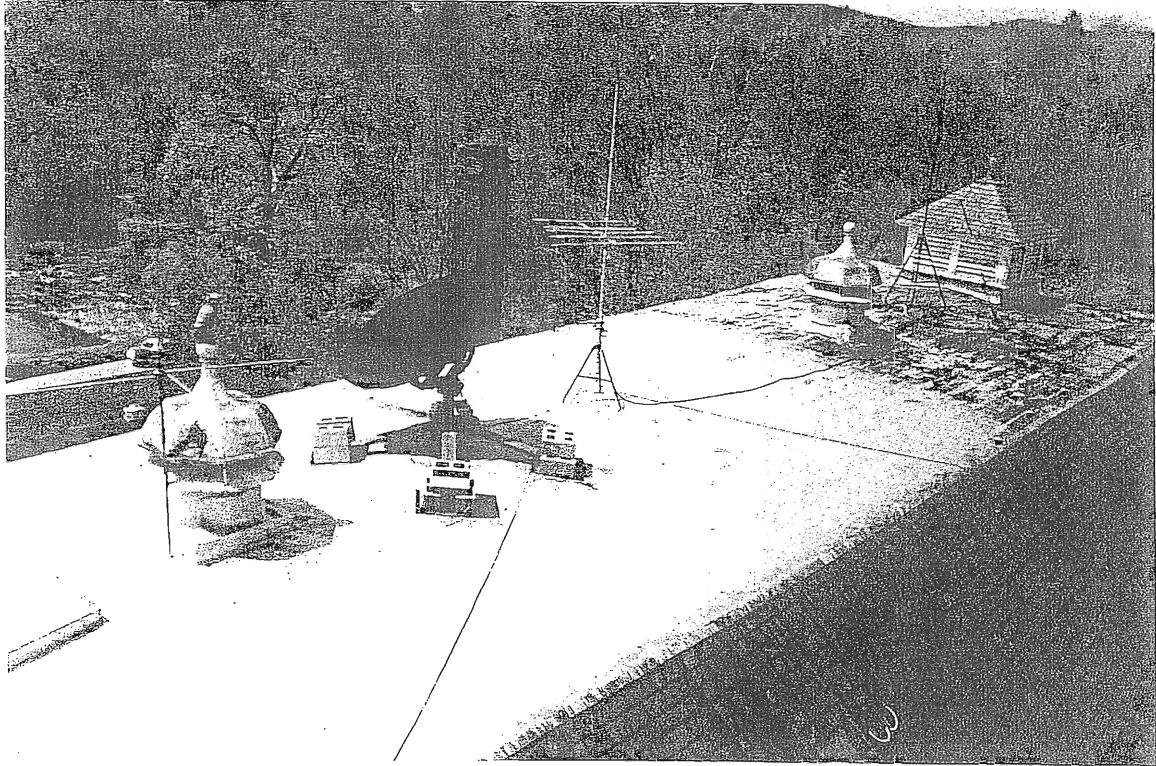
TOPMOST ROOF OF AUDITORIUM FROM BELL TOWER -  
LOOKING TO REAR (WEST)  
NOTE SLOPING SIDES WITH SLATE SHINGLES

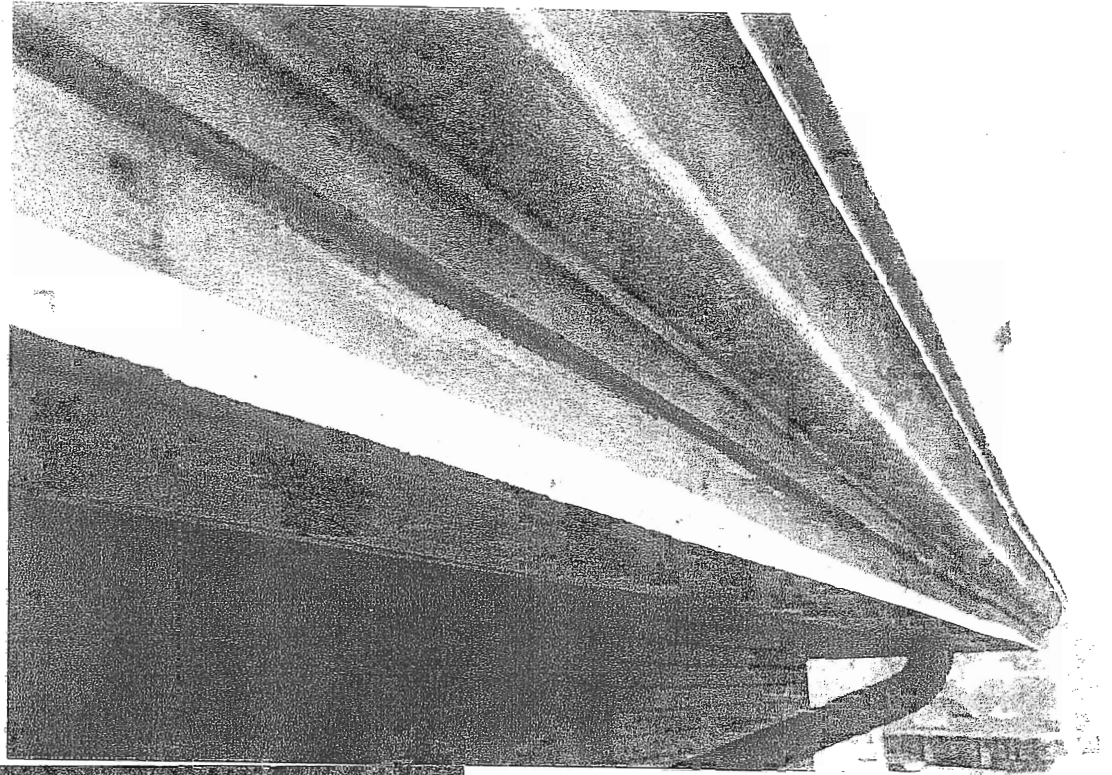
TYPICAL ROOF OVERHANG &  
UNDERSIDE OF SOFFIT -  
NOTE PANEL TRIM AND  
PAINT ALLIGATORING
